**JAMES CROSS**, Certified Marine Surveyor

June 12, 2013

Re: 2008 Jupiter 38 Forward Seating

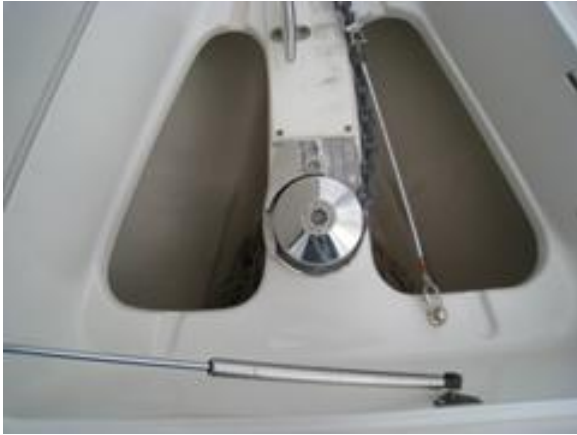
*Windlass mounted in anchor locker*

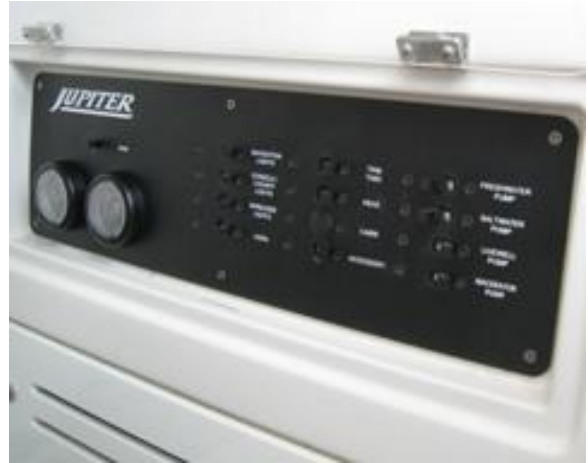
*DC control panel mounted in head*

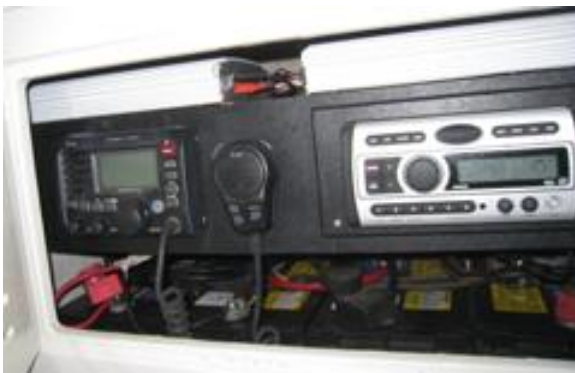
*Radio gear & batteries mounted in head*

Recommendations: Install backup ground tackle, insure that a complete Coast Guard Safety and Signalling package is aboard. Install appropriate AC hardware and circuit protection. Clean bilges. Repair cockpit entry door latch. Batteries may be original, expect to replace in near future.

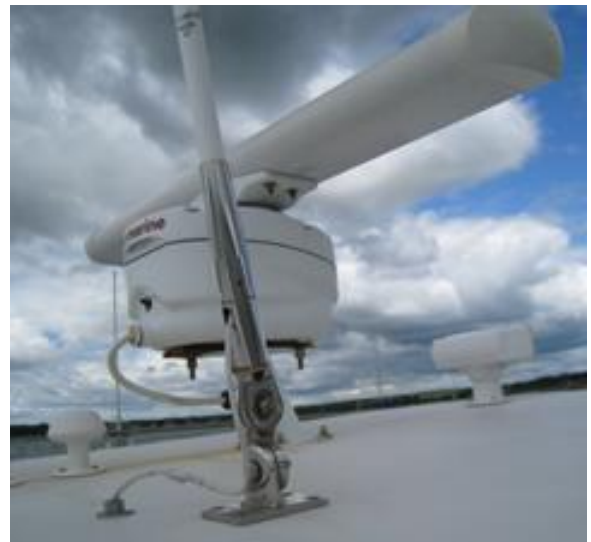
*Antenna hardware*

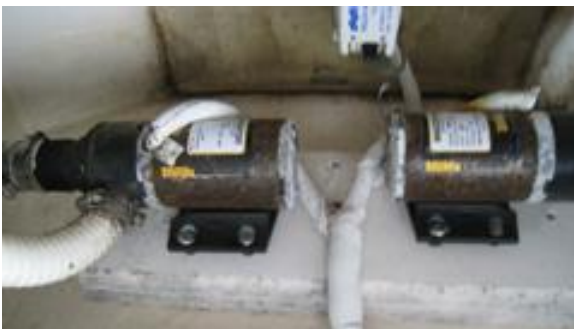
*Keep an eye on these motors, lots of corrosion.*

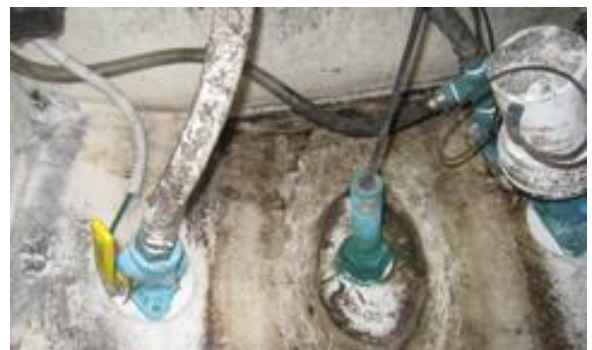
The aft gear compartment is also in need of cleaning, odor free, and free of any unessential material. It houses, among other devices, the various pumps and bilge pumps. The batteries are properly installed and secured. The battery connections are appropriate as are the cables. The electrical wiring and terminals observed throughout the vessel are in good condition. The throttle and gear linkages are in good order and work smoothly.

*All bilges should be clean*
