JAMES CROSS, Certified Marine Surveyor

Re: 2000 Beneteau First 40 Sloop

"SHADOW FAX"

This letter reports the results of a survey of the above vessel which was inspected on the 22nd of March, 2011, while hauled at the Borden Light Marina in Fall River, Massachusetts. You requested the inspection to establish its condition and value.

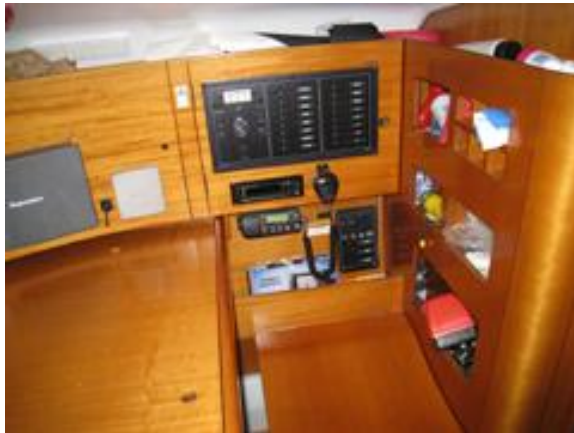
The interior, overall, is in excellent condition. This vessel was produced as a cruising/racing sloop, so the materials used during construction, both in and out, are heavy duty. The upholstery sections show light use. The entire sole is in good condition and shows no abuse. There are hull liners installed. The liners are clean and in very good condition. The head liner is clean and moulded into the deck composite. The bulkheads are 1/2 and 5/8 inch plywood. The bulkheads that do not form a part of a liner are ma-

hogany laminates with a Cherry finish. The bulkheads are bonded to the main structure and are secure. The combination of plywood bulkheads, proper glass tabbing, and nicely done joiner work make a very strong and rigid composite unit. The deck and overhead is supported by bulkheads and a compression bulkhead. The mast is supported by a stainless step on the keel structure. The entire bilge is clean and free from oil or debris. Access to the bilge is not limited. The bilge and inside surface of the hull are painted with white epoxy. There are two bilge pumps installed. A manually operated gusher amidships and an electric pump. The gusher is operated from the operating station. The hoses and related wiring and discharges are in good condition.

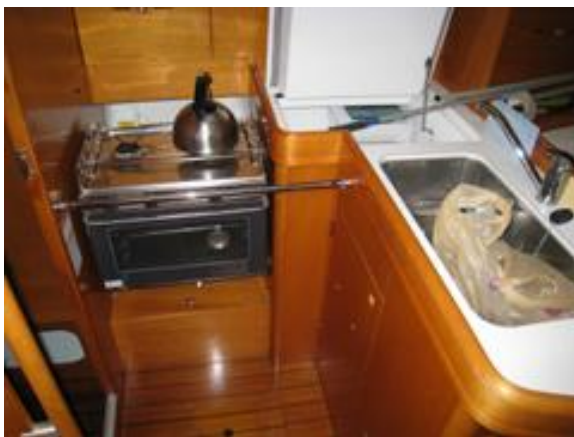
A large (12 volt refrigerator/freezer unit) is built in. The built in reefer and double stainless steel sinks are in good condition. The Graincoat counter tops are like new. There is a pressure hot and cold water system installed. The potable water system was not checked out. Closets, lockers and other storage areas are more than adequate through out the vessel. The CNG stove-oven is fed through proper lines and valves from the tanks, which are properly mounted, secured, and vented to overboard at the stern. The stove with oven and its related hookup are proper and secure. Devices were not checked while operating as the vessel is winterized.

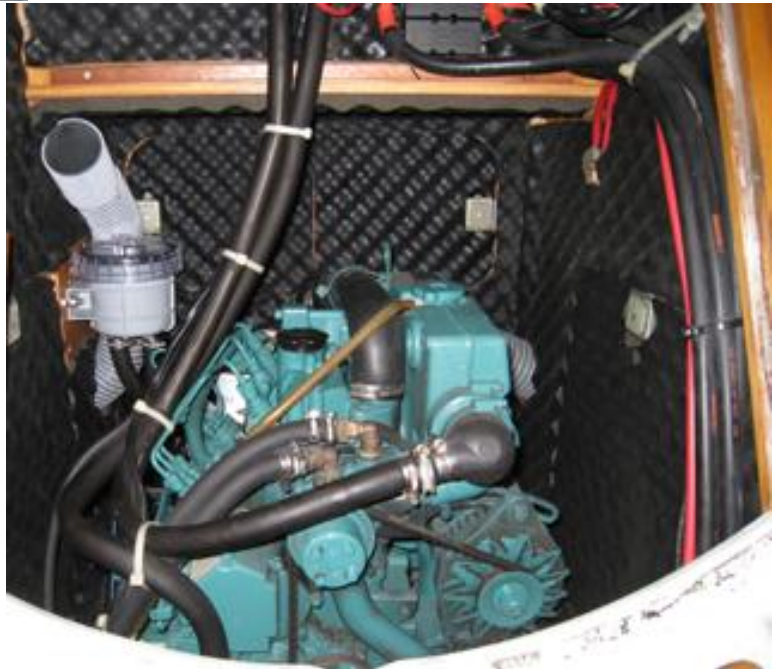
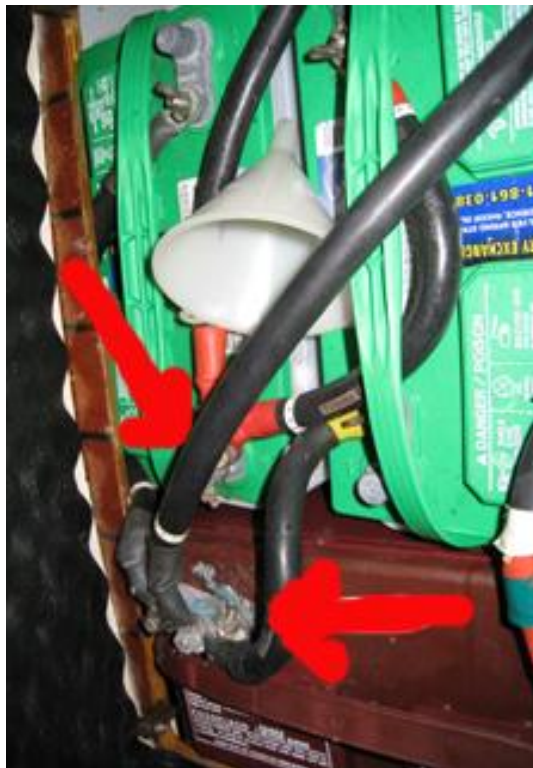
Propulsion is by the original 20 HP fresh water cooled Volvo Diesel engine with SailDrive and folding propeller. Engine instrumentation, consisting of a tachometer, gauges, and warning lights, are positioned at the helm for easy viewing

while under way. The engine was not tested during inspection but it does appear clean. The throttle and shifting levers worked smoothly. The engine intakes salt water via the Sail Drive and on to a large strainer and on to the heat exchanger. The intake is secure, and double clamped. The exhaust system is in good shape. The engine compartment is clean and free of any unessential gear. The plastic fuel tank is secure. The fuel shut-off is easily accessible. The fuel feed lines, filters and the fill, are in good condition and secure.

Recommendations: Ensure that a complete Coast Guard Safety and Signalling Package is aboard. Replace rusted clamps and double clamp exhaust system hoses. Have yard check fuel lines as they appear original. Install backup ground tackle.
