JAMES CROSS, Certified Marine Surveyor

Re: 1981 Bristol 455 Sloop "PANDORA"

This letter is an update of a survey performed by me on this vessel in February of 2010. During the past year this vessel has undergone a complete professional refit. Page eight and nine detail the exact refit. Page ten, a Photos page, will validate much of the work as it proceeded along to completion. The final results of the inspection indicate a professional work ethic with little regard for expense. The final inspection took place on the 16th of August, 2011 while afloat at Brewers Cove Haven Marina in Barrington, Rhode Island. You requested the inspection to establish its condition and value as you intend to increase the insurable value.

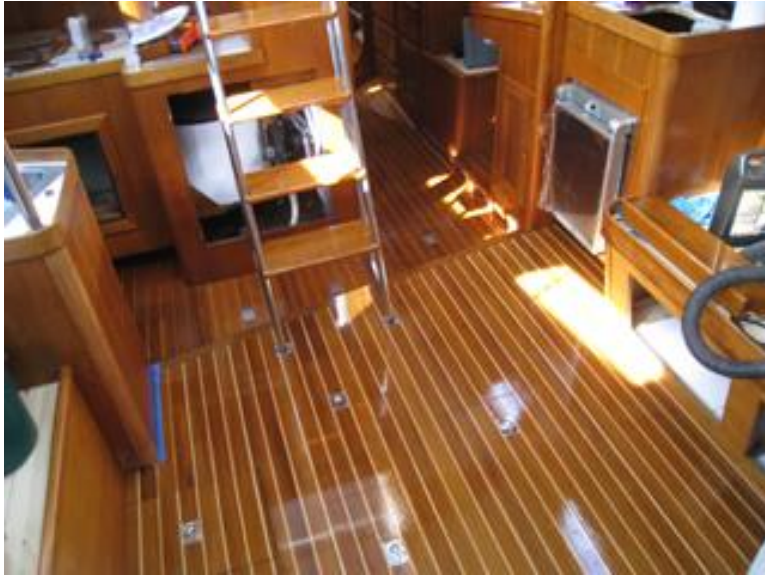
The interior joiner work and trim, as evidenced by the photo at left, has been completely replaced or refinished.

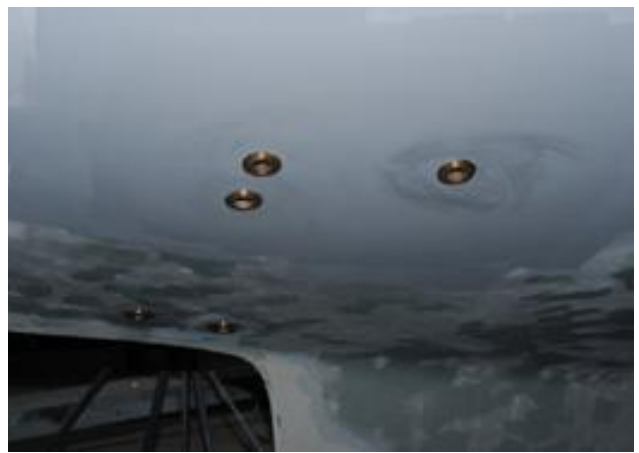
Deck holes drilled and cleared of coring – including to ½” all around the hole – and then filled with epoxy slurry using an injection method to fill all voids. Holes re-drilled through pure epoxy – no possibility of water exposure to deck coring now.

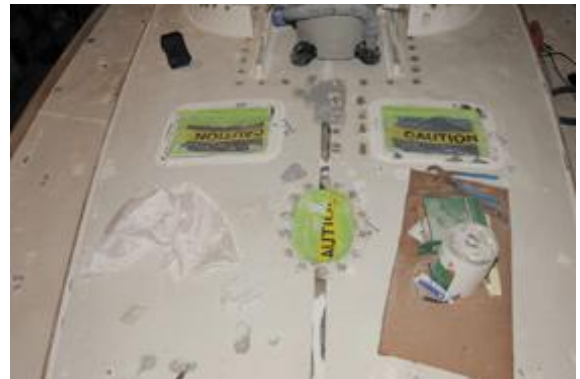
new head windows. These will eventually replace all the small ports (12 in total).

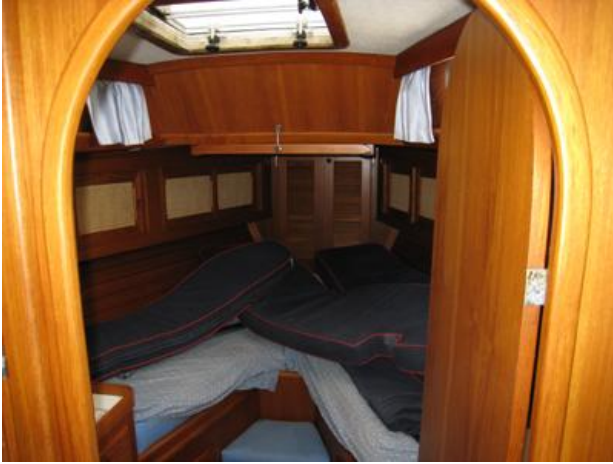
Pictured at left are the two large berths. These areas are nicely finished and in good shape, structurally. There is adequate lighting and ventilation in these areas. The sole in these areas is properly supported, nicely finished and in overall good condition. Safety Equipment
