Re: 1986 Buddy Davis 47 Sport Fish

"SON OF A SAILOR"

This letter reports the results of a survey of the above vessel which was inspected on the 23rd of June, 2011, at Brewers Marina in Warwick, Rhode Island while afloat. You requested the inspection to establish its condition and value.

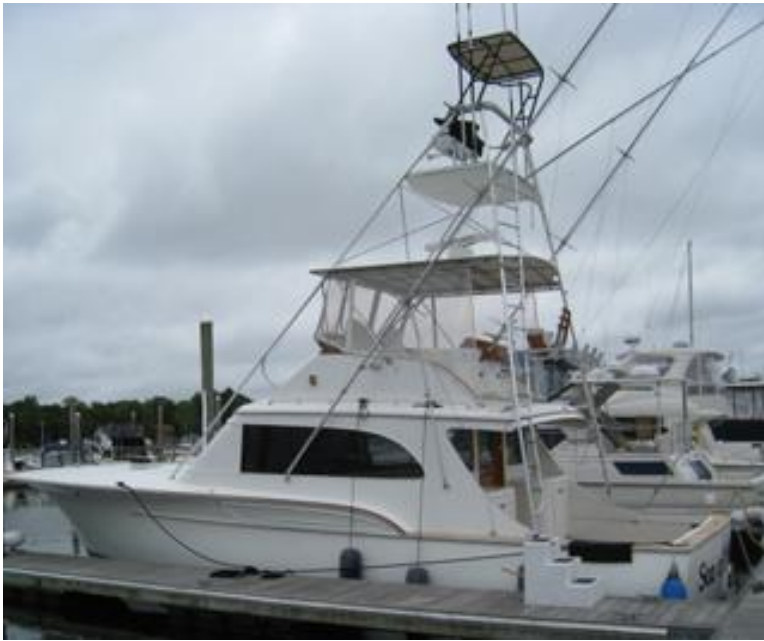
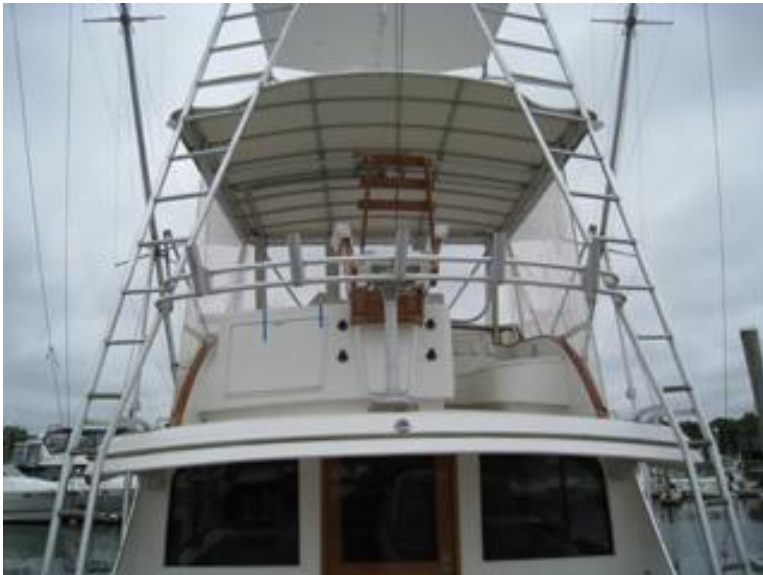
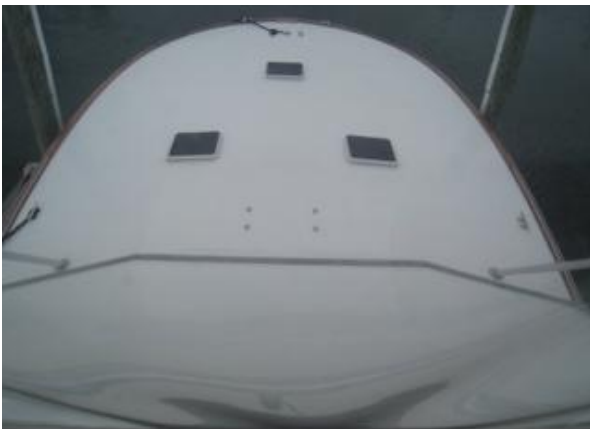
## Hull and Structures

The hull is a heavily laid-up polyester laminate reinforced with fiberglass matt in a modified vee configuration. The hull and fiberglass structures were laid-up by hand. The hull below the waterline is solid fiberglass. Closed cell foam, balsa and plywood cores are used in the topsides and superstructure. The pilot house and boat deck are constructed of solid fiberglass with an end grain balsa core. The structural integrity of the hull is good. The bulkheads and interior tabbing are in good condition and secure. All bulkheads are marine grade plywood. The bulkheads are properly tabbed and rigid. All stringers and frames are mahogany. The freeboard hull finish is the original white gel coat. The finish is in good condition, overall, with just a few mars and scratches. There are only minor abrasions on the freeboard part of the hull. The hull-deck attachment is secure, sealed, and trimmed with a stainless steel rub rail. I was unable to locate any delamination or separating of glass, including the engine bearers and stringers. The interior surface of the hull, as can be observed at the bilge area, is epoxy coated and in very good condition. The bottom (sections below the water line) was not inspected. All through hulls below the boot are bronze and in good condition, and their related valves are working properly. There are adequate large chrome plated bronze cleats provided for docking. The cleats are secure and properly backed. The bridge unit is properly secured to the structure. There is a stainless steel rail installed at the bridge, and it is secure. There is a good quality stainless steel bow pulpit properly installed, in good condition, backed, and secure. The stainless tower structure to the bridge and other stations is in good condition and secure.

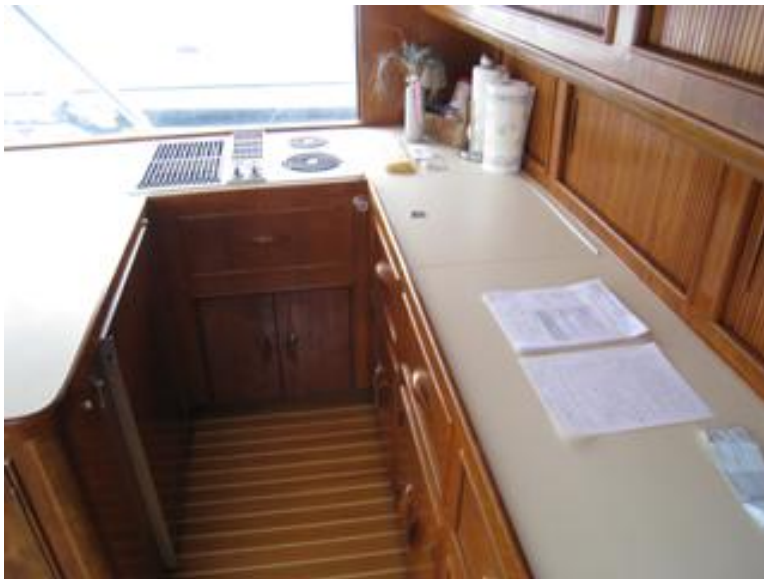
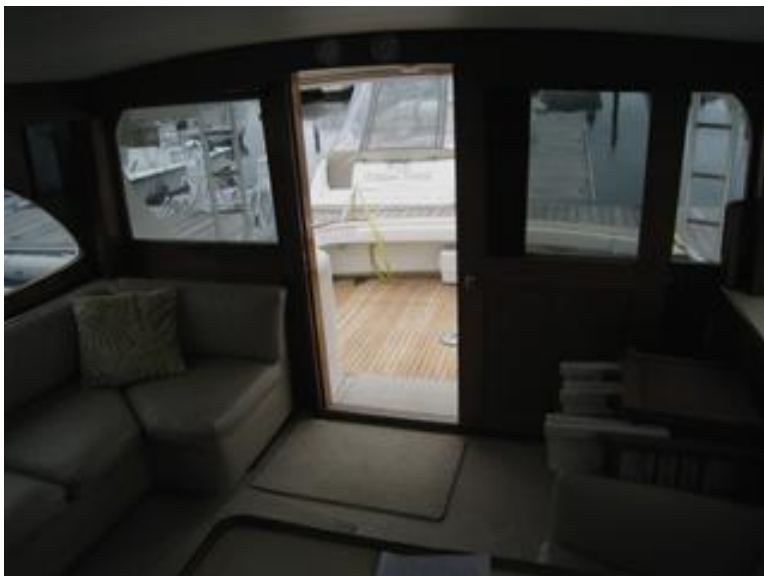
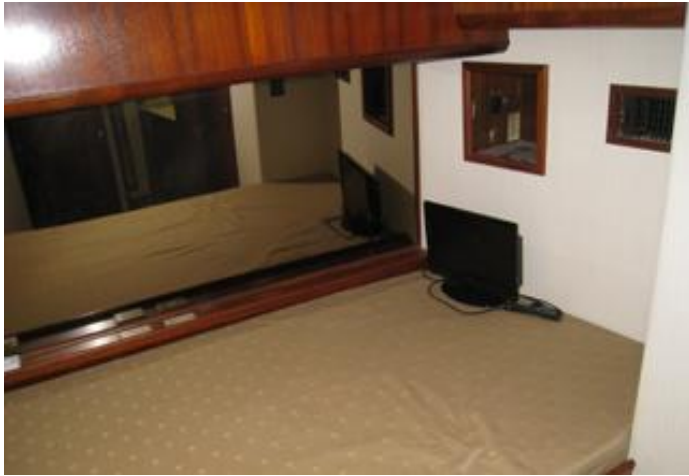
## Main Salon and Galley

The salon and galley are forward on the main deck. This area is large, nicely finished in Formica, teak, and mahogany and in good condition. Continuous color keyed Berber carpet has been professionally installed and appears lightly used. No rot was detected at any location. This area was checked for excess moisture content in all partitions, the overhead, and all glass surfaces. All checked out fine. There was no delamination of Formica.

The color keyed upholstered sections are in like new condition and show very little use. The plywood deck in this area is properly supported and in excellent condition. Lighting is good throughout the vessel.

The stove and reefer system appear in like new condition. The stainless sink and related hardware are in good condition. The galley sole is Teak and Holly over plywood, well supported, and in excellent condition. As the photos indicate the interior is well coordinated with upholstery, carpet, and Formica all in sync.

The Main Salon and Galley area, overall, is in excellent, lightly used condition.

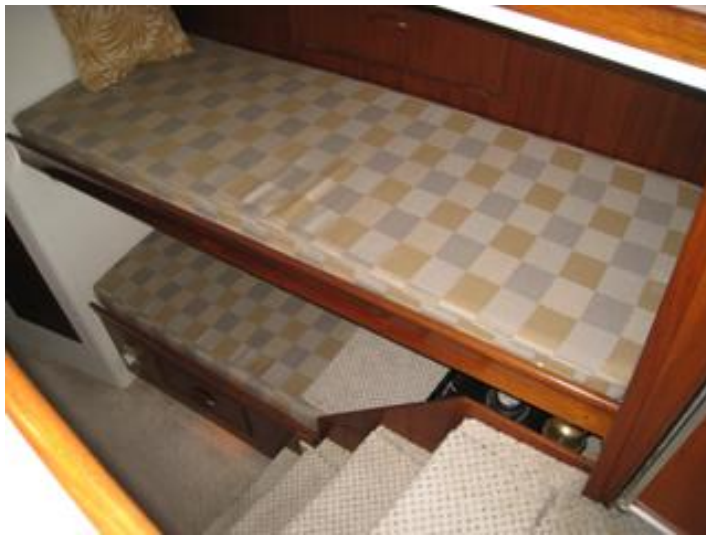
### Owners stateroom

A large owners stateroom is located beneath the forward deck. This area is clean, nicely finished and upholstered. There is adequate lighting and ventilation in this area. The carpeted, plywood deck in this area is properly supported, nicely finished and in overall excellent condition. Some of this area is sheathed with a vinyl like fabric, mahogany, and other surfaces are teak. I was unable to locate any excess moisture on any surface in this area. There is a head with shower and hand basin located in this area.

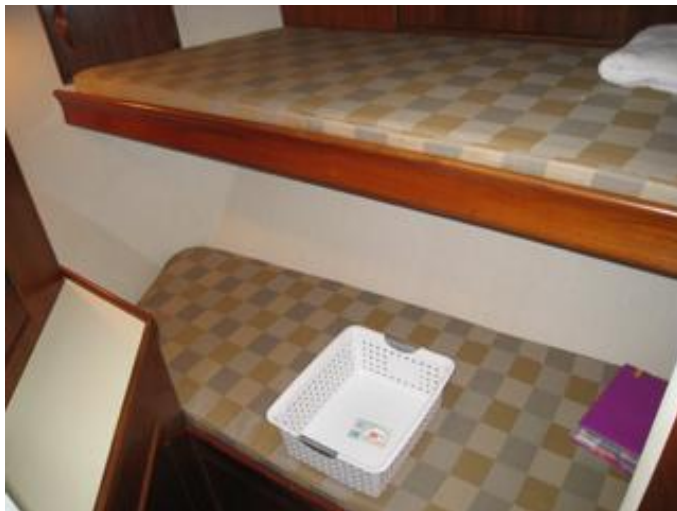
### Forward Berths

A second and third large berth area lies forward at the bow. Pictured at left. These large area houses two single berths each and are equipped with a second head with shower. This compartments are clean, nicely decorated and carpeted. All jointer work is mahogany and maintained to a bright finish. The vinyl headliner is also in very good condition. As with all other compartments this area is heated and air conditioned on a single thermostat. Lockers and drawers are adequate. Overall this area is in very good condition.

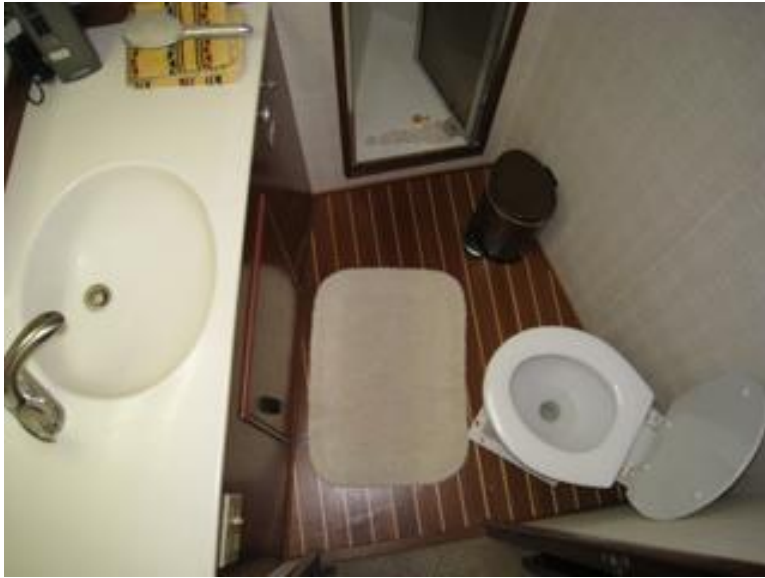
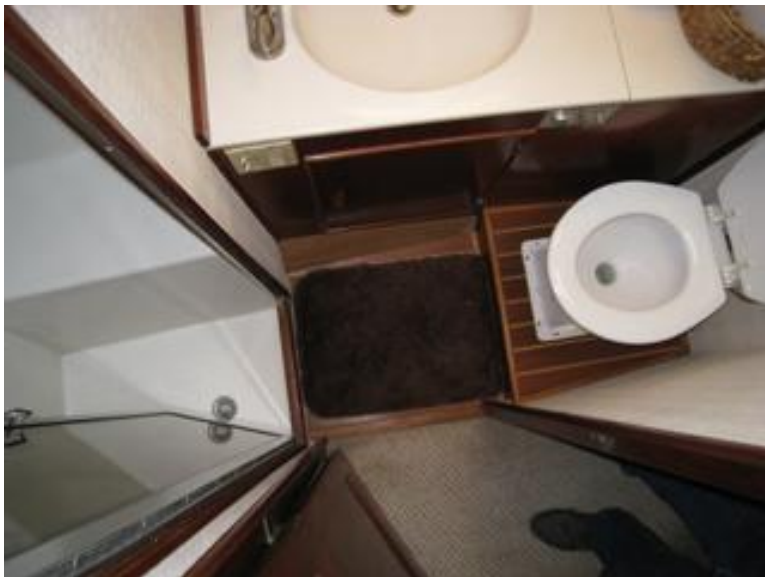
## Heads

This vessel is equipped with two full size complete heads. All are equipped with electric marine toilets and macerators which are connected to the septic system via appropriate plumbing devices. No septic odor was noted at any plumbing joint. All showers are drained to individual sumps and the sumps are then pumped overboard. Both head areas are neat and clean, and no rot was observed in any area. The toilets, hand basins, and their related fittings, including overboard discharges and through hulls, are in good shape. The marine toilet system and in excellent condition. The heads are clean and well kept. The entire area is free from rot or any type of blistering and is in excellent condition

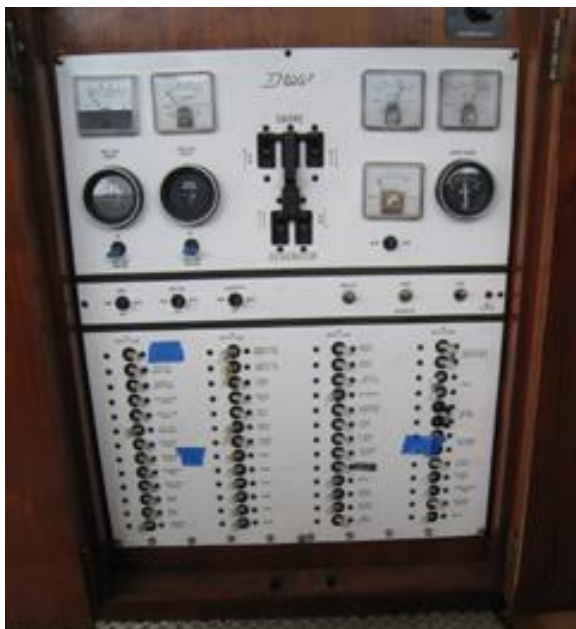
## Electrical and Electronics

The combination AC/DC and power panel is mounted in the main salon and is easily accessible. The breakers and circuits were found to be in operating condition. There are two 3 position battery disconnect switches mounted on a frame in the engine compartment, and they are in good condition and secure. The 12.5 KW Westerbeke was not tested, but appears in good, well maintained condition. Three individual heat/air unites are in good working order. The navigation lights conform to the CFR and ring out okay. There is a VHF transceiver and a depth finder, properly installed. The electric motor which operate the fresh water system operates properly. An automatic battery charger is properly installed. A proper bonding system is not installed. All electronics was not checked out.

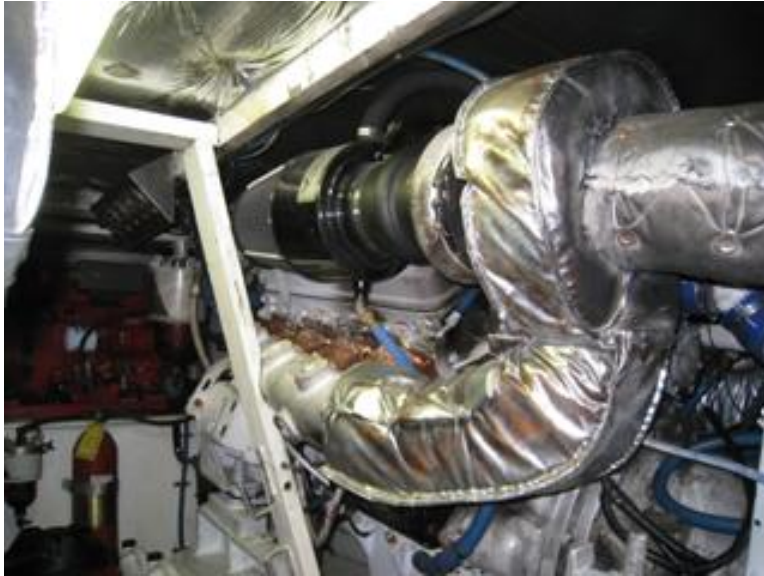
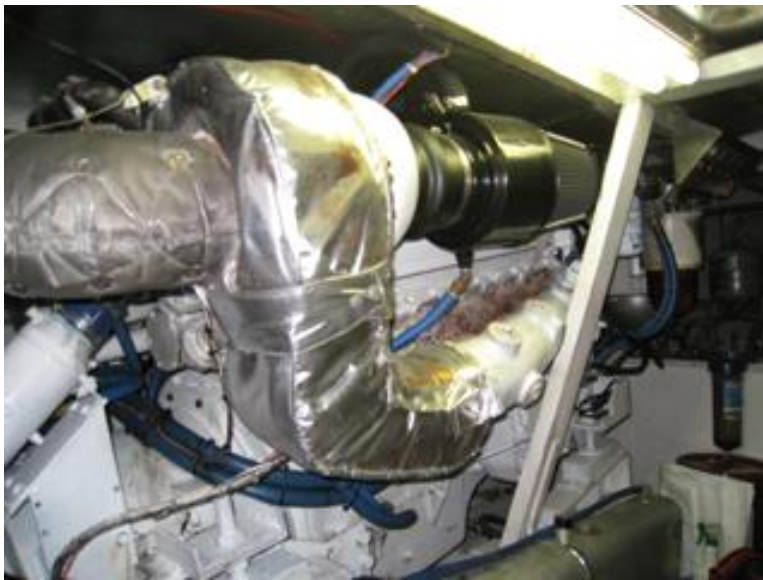
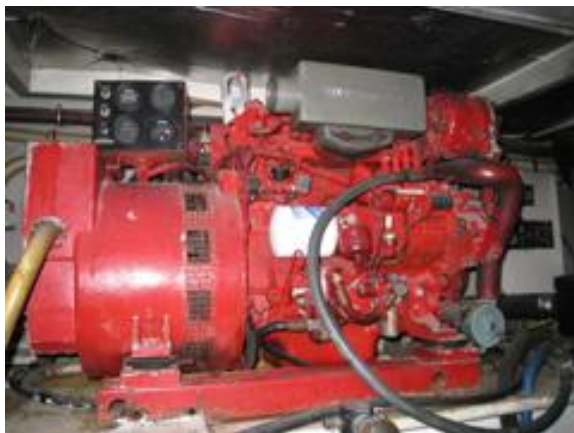
## Mechanical

Propulsion is by a pair of counter rotating fresh water cooled turbo charged Detroit eight cylinder diesel engines (8V92TI) with Twin Disc reduction gears coupled to monel shafts. The shafts, and logs are in good condition as can be inspected from inside. The engines and gears are clean and appear well maintained. Ventilation to the engine spaces is adequate. The exhaust system is cast, stainless, and rubber, heavy duty, and in good condition as can be seen. The system clamps are not all double. All through hull fittings below the water line including the valves are bronze and in good working condition.

The engine controls and cables are smooth operating. The engine compartment is epoxy painted, sound and sturdy. The bilge in this area is clean or free from unessential gear. There are auto/manual bilge pumps installed and working in this area. The custom hydraulic steering gear is in good condition and operates smoothly from all stations.

The batteries are properly connected to the approved three way switches and then on to a series of custom breaker panels. The wiring and terminals that could be observed are in good condition. The shore power system is functioning properly. The automatic battery charger was working properly.

Only portions of the fuel tanks can be inspected as they are built in to the structure. The fuel lines are of the approved type including the flex sections. The filters/separators and distribution manifolds are in good order. The fuel fills, vents and shut-offs are in good condition.

1. Install backup ground tackle.
2. Replace fatigued cooling intake hose on port engine
3. Ensure that a complete Coast Guard Safety and Signaling package is aboard. Service battery terminals.
4. Have auto fire suppression system inspected and tagged
5. Keep unnecessary material out of engine room.
