JAMES CROSS, Certified Marine Surveyor
19 Nooseneck Hill Rd, West Greenwich, RI 02817
Phone (401) 397-5040
Member Association of Certified Marine Surveyors//ACMS-USA.COM
Check us out on the web at www.jimcross.net

Re: 1991 Freedom 45 Center Cockpit

"WHITE CAPS"

This letter reports the results of an upgrade to a survey that was conducted in 2008. This vessel was reinspected while afloat on the 11th of October, 2011 at Brewer's Wickford Cove Marina, in Wickford, Rhode Island. You requested the inspection to establish its condition and value.

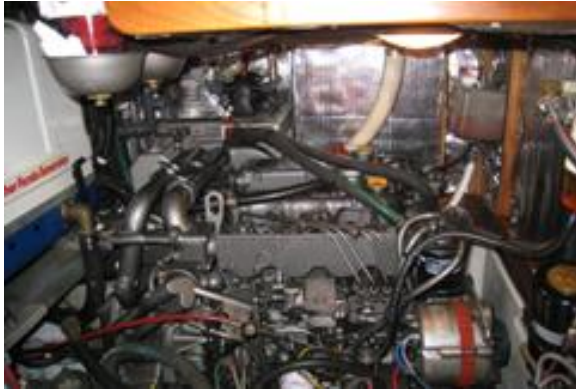
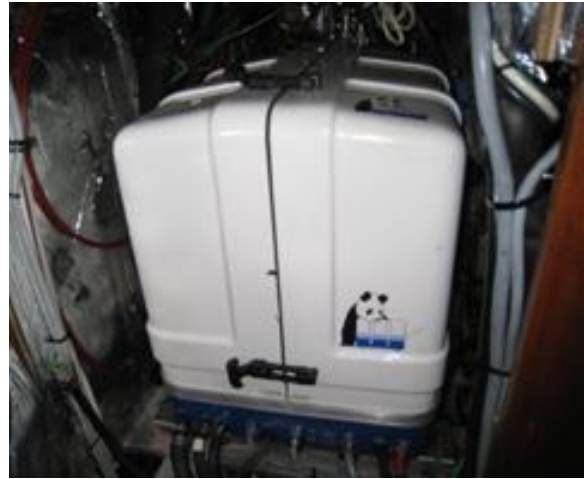
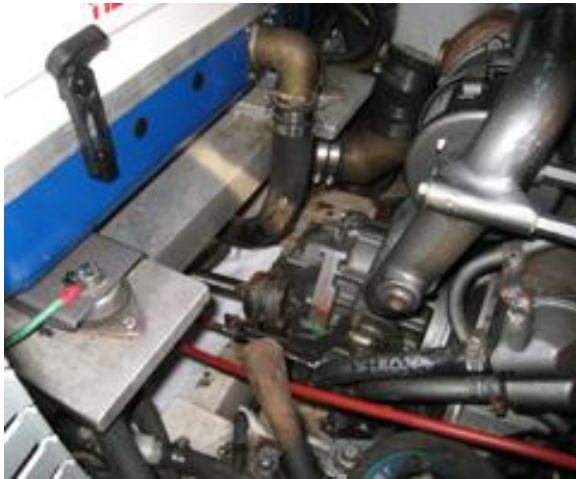
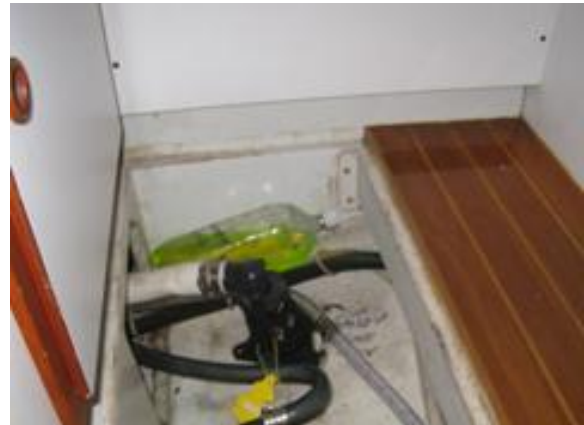
Propulsion is by a 75 HP turbo charged fresh water cooled Yanmar diesel engine with Hurth reduction gear, coupled to a monel shaft and then to a three blade feathering propeller. The shaft and shaft log, are in good condition. The engine and gear appear in good condition, very clean and well maintained. Ventilation to the engine spaces is adequate. The exhaust (most can be inspected) system is cast and rubber, heavy duty, and in good condition. The system clamps are now all doubled and have had recent service. All through hull fittings including the valves are secure. The engine controls and cables are smooth operating. The engine compartment bilge is epoxy painted, sound and sturdy. The bilge in this area is clean. There are adequate bilge pumps installed and working in

this area. There is no oil in the bilge. All fuel and water tanks are in good condition as can be inspected. The fuel lines, including a Racor filter are approved type and in good condition. The flex fuel line appears to be a recent upgrade. The fuel fills, vents and shut-off are in good order.

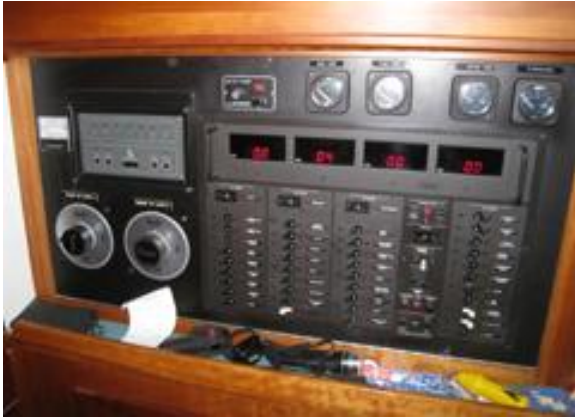
The batteries appear fairly new and are in good condition and properly connected to the approved three-way switches and then on to the custom breaker panel. The batteries are properly secured and covered below the salon sole. The wiring and terminals that could be observed are in good condition. As part of the recent upgrades, all of the electrical wiring has been properly harnessed. The shore power system overall is in good condition as are the cables. The automatic battery charger was not checked out. The navigation equipment and electronics, was checked out and all is working. The electric anchor windlass is in excellent condition and secure. The Auto pilot hardware is properly installed and appears in good condition. All of the electronics devices were checked out.

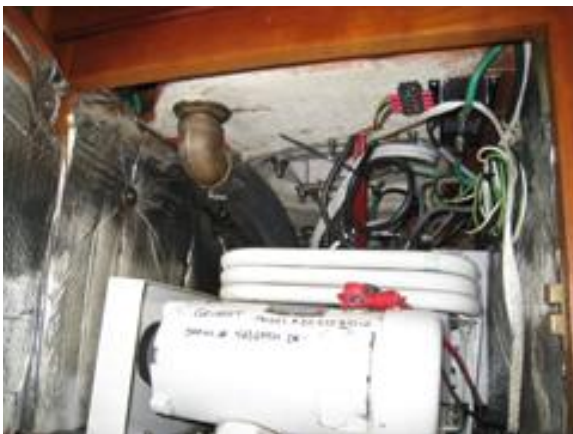
The water heater is in good condition and properly secured. Only portions of the surface can be observed of both aluminum fuel tanks, which appear in good condition. The water tankage is adequate for cruising. The water fill over flows into the bilge, via the inside surface of the hull. Only portions of the surface can be observed of the two built-in water tanks. The surfaces that can be inspected look good.

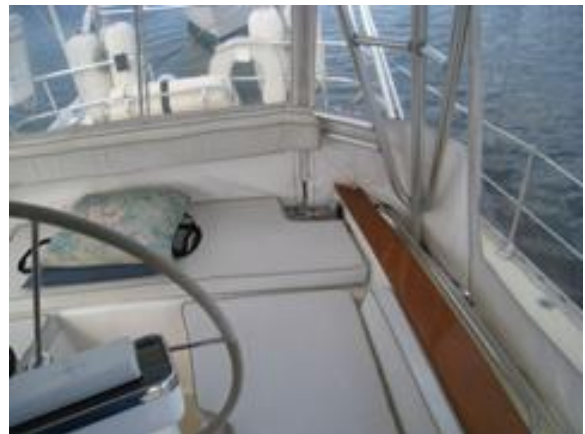
Cockpit, looking aft
