Loading survey report for un-containerized cargo

Single masted race yacht 'ROSEBUD' Loaded on Wednesday July 15, 2009

Name of Ship: MV 'SPUIGRACHT' Loading Port: Portsmouth, Rhode Island, USA  
Destination port: South Hampton, UK

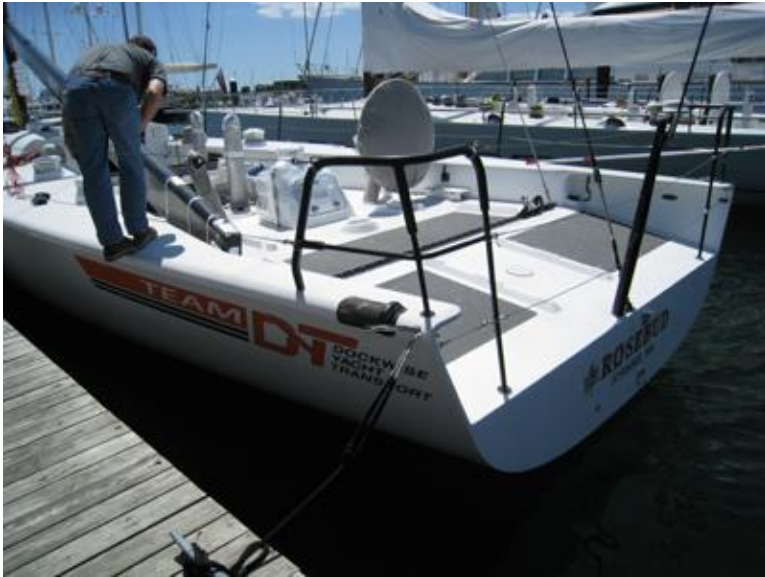
10.0 Vessel at berth.

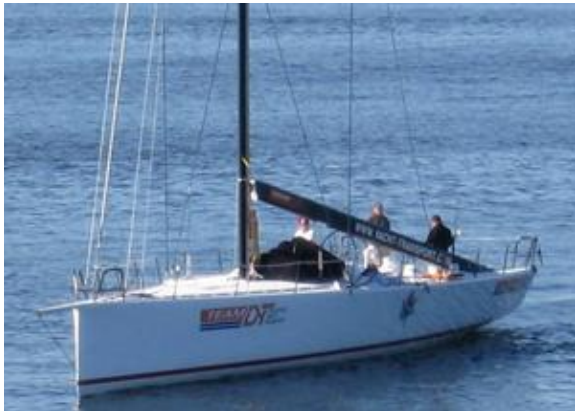
10.1 Vessel delivery.

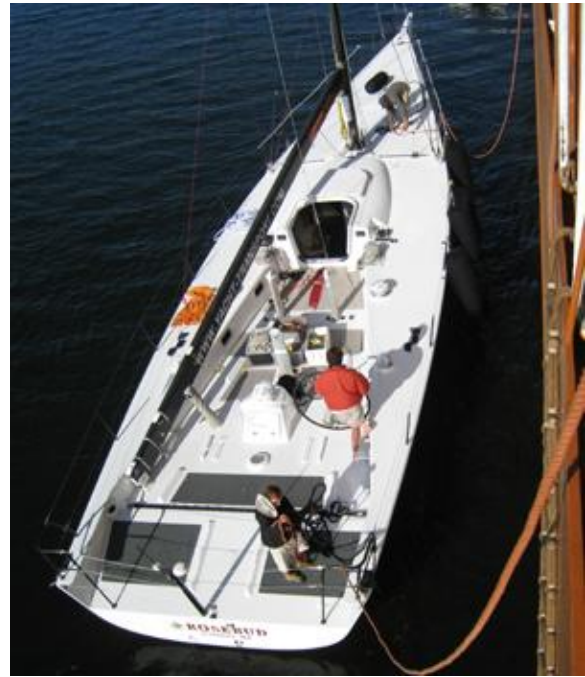
10.2 Vessel delivery.

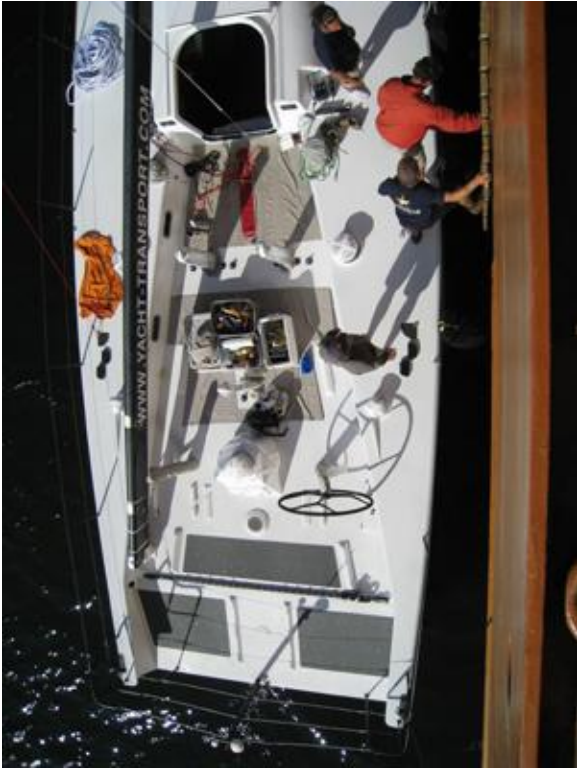
10.3 Aft and Midships deck view.

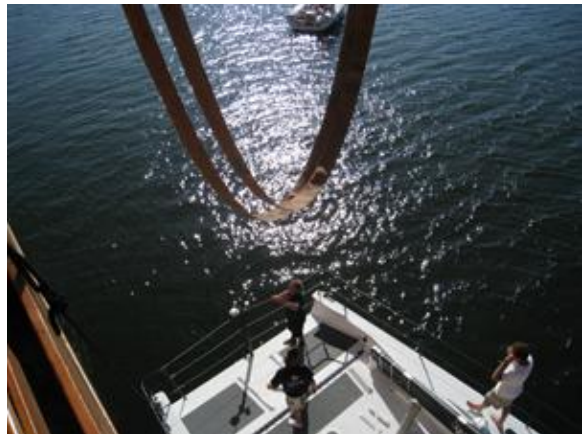
10.4 Lifting gear prepared on arrival.

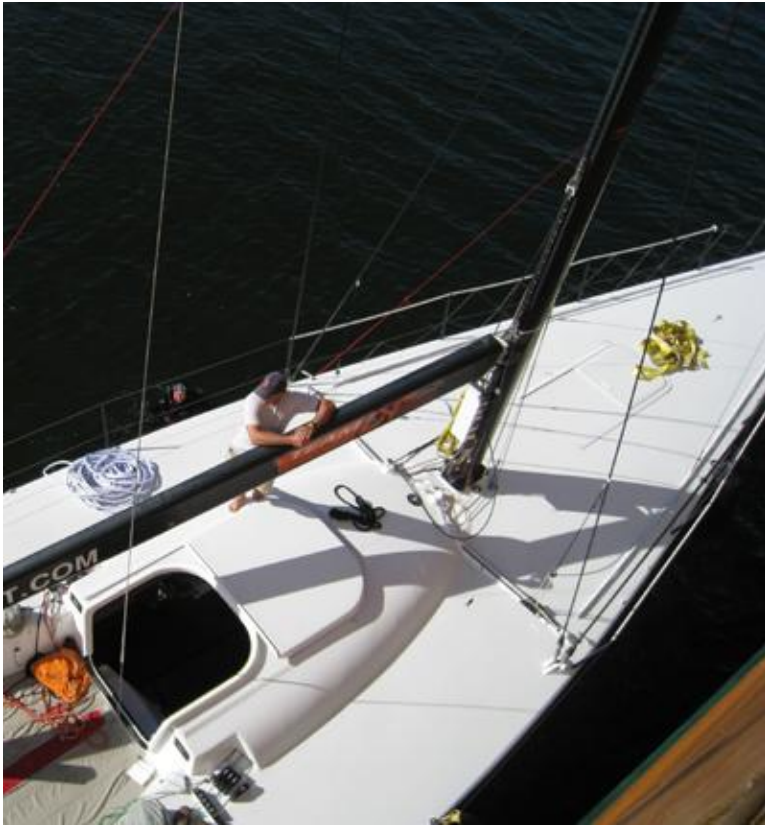
10.5 Foredeck view

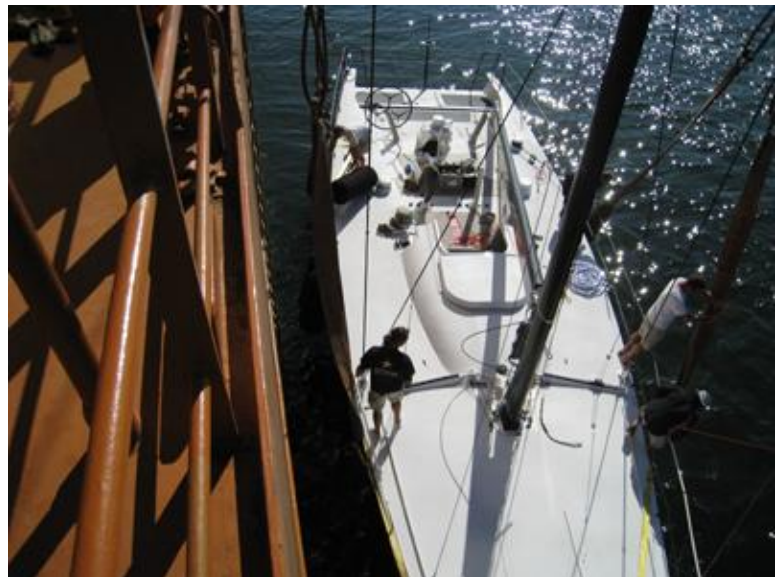
10.6 Lifting gear rigged.

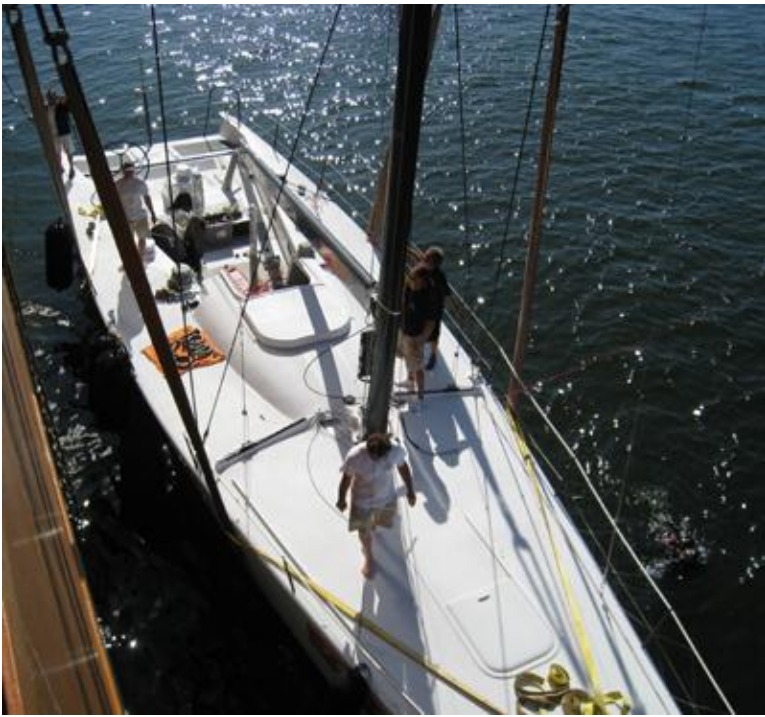
10.7 Initial lift.

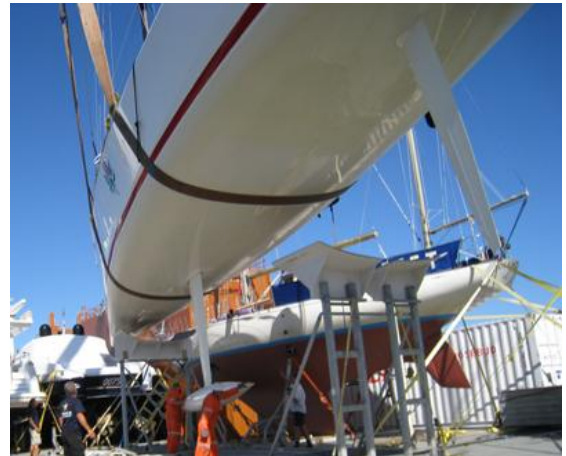
10.8 Positioning over cradle.

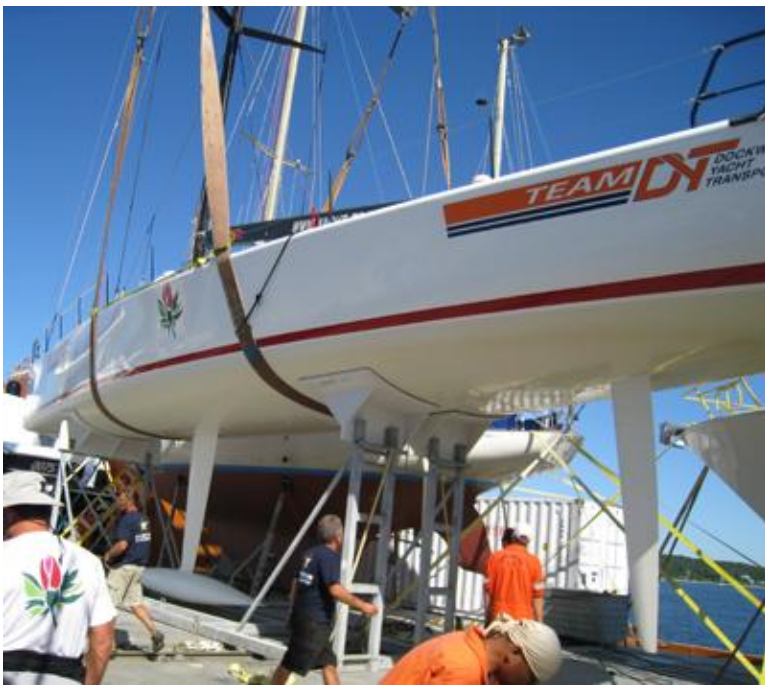
10.9 Vessel in cradle.

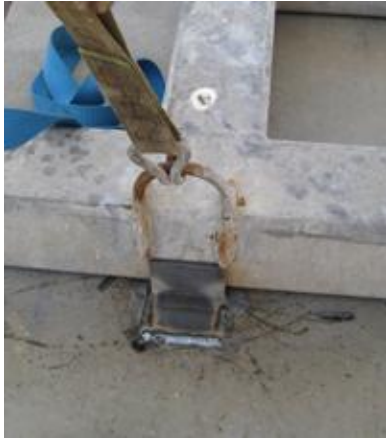
- 7.3 Securing materials used include:  
Vessel to deck: 10 x 2.5-ton webbing straps provided by yacht owner and ships on board supplies, tightened by hand with ratchets.  
Cradle to deck: 10 x 2.5-ton webbing straps along with welded steel corner brackets and welded hold down brackets fabricated by the ship crew.  
Keel to cradle: 2 x 2.5-ton webbing straps provided by yachts crew, tightened by hand with ratchets in belly wrap formation.

10.10 Sample of cradle positioning welds.

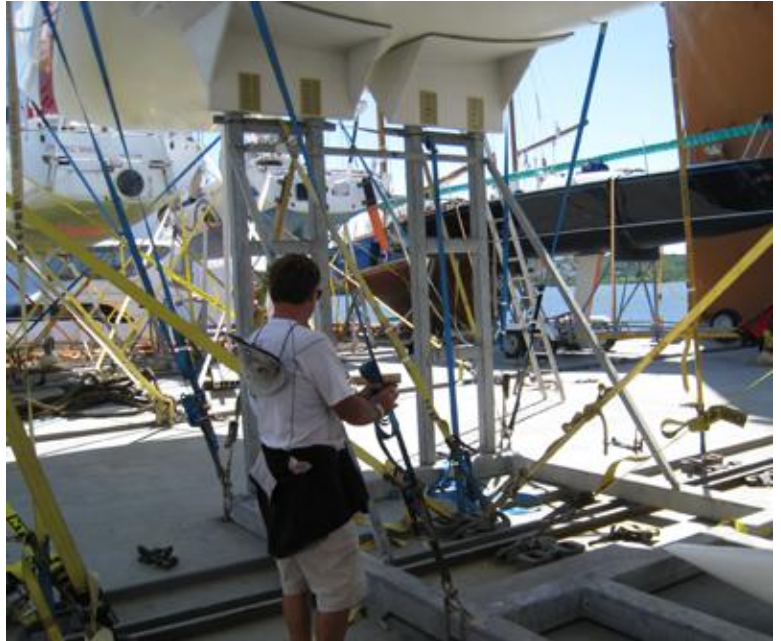
10.11 Vessel secure.
