JAMES CROSS, Certified Marine Surveyor
241 Nooseneck Hill Road, West Greenwich, RI 02817
Phone (401) 397-5040
Member Association of Certified Marine Surveyors//ACMS-USA.COM
Check us out on the web at www.jimcross.net

Re: 1996 Mainship 47 Motor Yacht "LION CREST"

This letter reports the results of a survey of the above vessel which was inspected on the 31st of March 2011 at the Oak Leaf Marina in Old Saybrook, Connecticut while afloat. You requested the inspection to establish its condition and value.

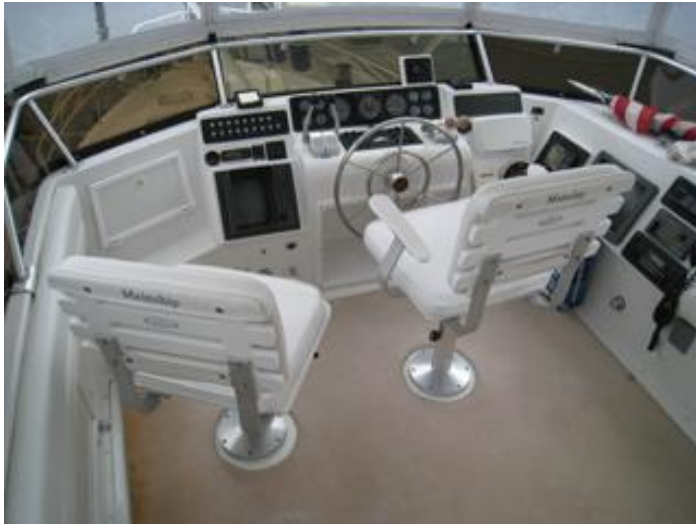
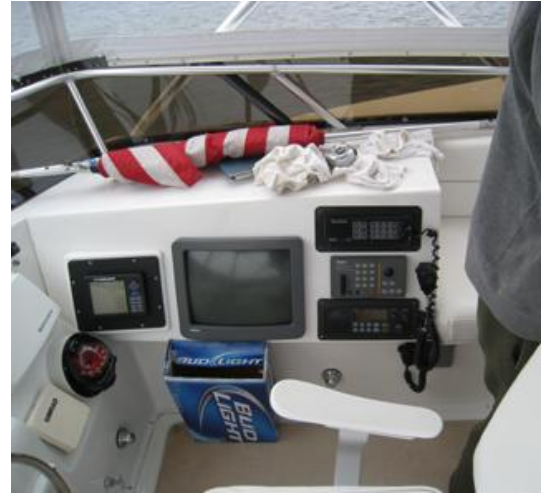
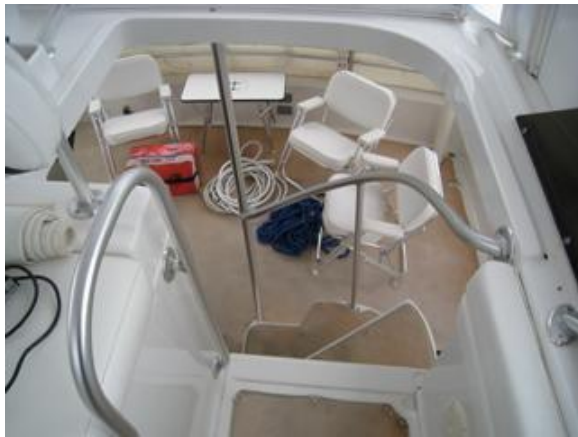
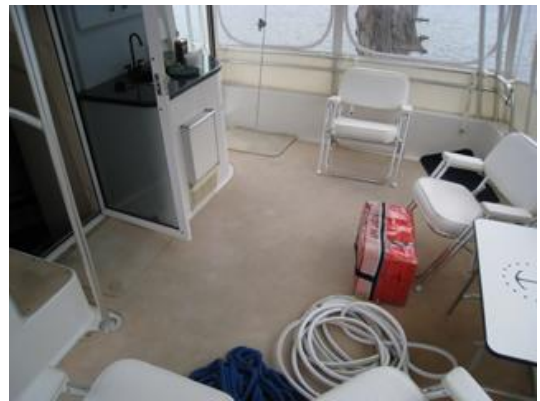
Sundeck, Aft deck, and Bridge Operating Station

The bridge operating station is well designed and the controls are easy to operate. The upholstery is in very good condition overall. The compass is accurate on its present heading. The shifts and steering are also smooth operating and in good condition. Steering is hydraulic and the related lines are in good condition. There is a complete color keyed canvas enclosure, that covers the entire operating station and bridge area. The canvas enclosure, and supporting structure appear to be a recent upgrade. The bridge is equipped with stainless life rails which are secure and properly backed. Also mounted on the bridge is a platform and davit for the 2005 ten foot hard bottom tender. The davit is well supported through to below the main deck. Overall, the bridge, including the operating station and upholstery is in excellent condition.

The sundeck area is in good, clean condition and free from any damage. The deck, rails and structures appear lightly used and are in very good condition.

The aft deck is equipped with a transom entry door which is in good shape and functional. The aft deck is provided with overboard drains, port and starboard. The cockpit trim and furnishings are in excellent condition. Overall the Sundeck and Aft deck and all walkways are secure and in excellent condition.

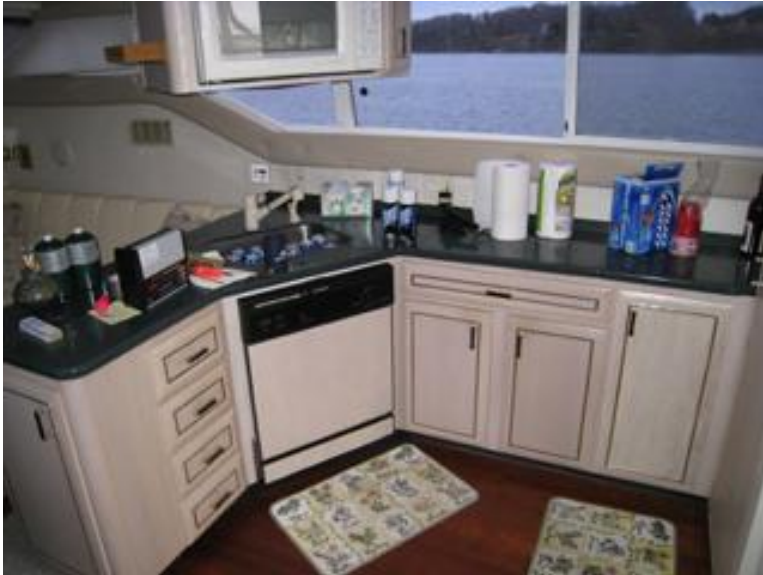
Galley/Dinette

There is a complete inventory of full size galley appliances stove with oven, refrigerator, microwave oven which are in lightly used condition. The counter top in the galley is comprised of Corian which is in good shape. There is a large sink located between the stove and refrigerator in the galley area. The sink and its related faucets and over board drain are in good condition and clean. The sole in the galley and forward is also Cherry and is in excellent condition and secure. No rot was found in any deck timbers or supports. The galley is located a few steps forward and below the main salon and dinette. The galley and dinette (space for four) , overall, is in excellent condition.

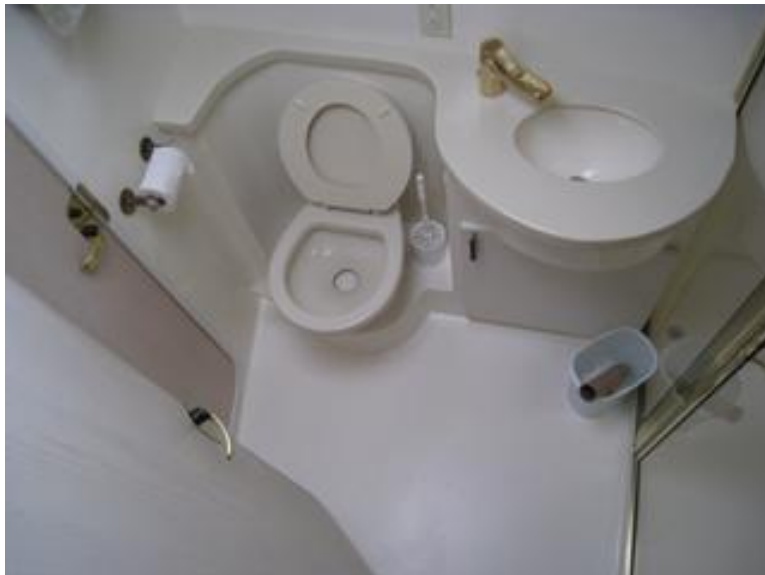
Forward berth and head

A queen size bed is located beneath the forward deck. This area is clean, nicely finished and upholstered. There is adequate lighting and ventilation in this area. The deck in this area is properly supported, nicely finished and in overall good condition. Some of the this area is sheathed with vinyl and some in nylon, the jointer work is plastic laminated to plywood. I was unable to locate any excess moisture on any surface in this area.

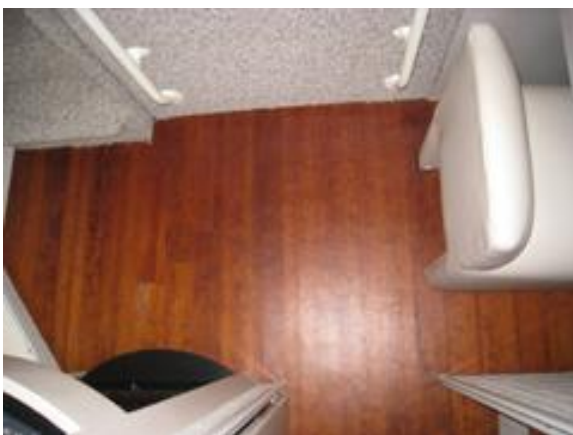
The forward head with shower (Photos on Page 6) and hand basin is located in this area. The marine toilet, hand basin, and their related fittings, including overboard discharges and through hulls, are in good condition. The toilet is equipped with a macerator and proper holding tank system. The head is in need of cleaning. The entire area is free from rot, any type of blistering and in good condition.

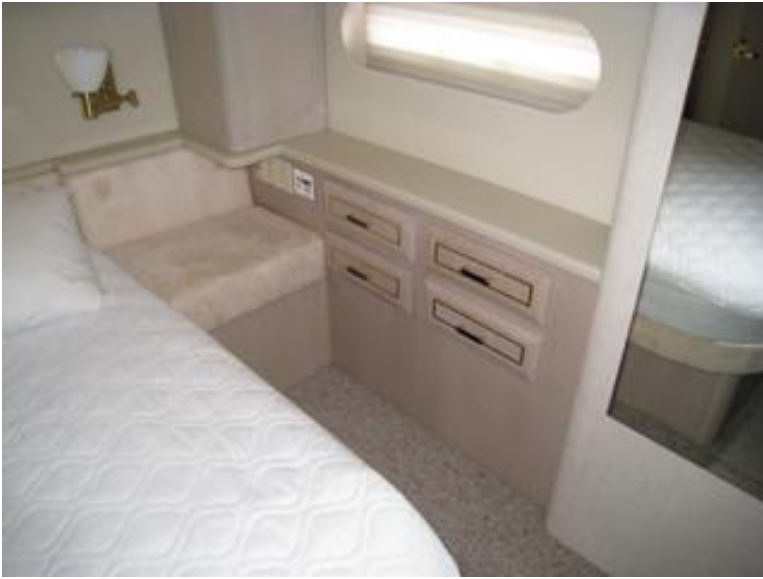
Aft berth, head, and shower

The head is also a multi piece laminate enclosure with built in fiberglass shower. It is properly secured to the hull and forms an integral part of the hull unit. It houses a vanity with hand basin, marine toilet and shower. It is in good condition. There is a macerator unit installed. Functionality of the head plumbing is (all operating properly).

Dockside pump out was not checked out. The overall condition of this aft area is good and is in the same condition as the forward areas. No septic odor was noted.

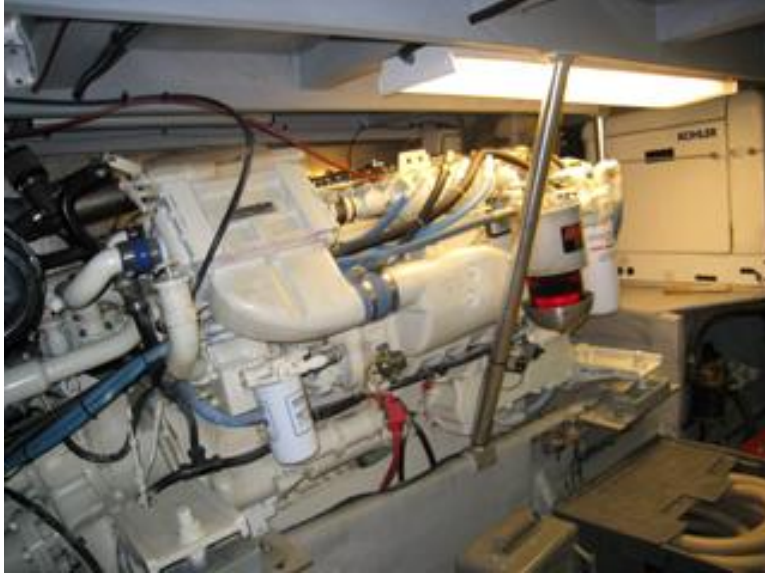
Propulsion is by a pair of fresh water cooled , turbo charged, 671 Detroit Diesel engines with reduction gears , coupled to monel shafts and on to bronze propellers. The shaft logs are in good condition.

The engines are rated at approximately four hundred and fifty horsepower each. Visual inspection of the engines, oil, filters, and related connections show no signs of abuse. The fuel lines are of the approved type and are in good condition. The
