JAMES CROSS, Certified Marine Surveyor
241 Nooseneck Hill Rd , West Greenwich, RI 02817
Phone (401) 397-5040
Member Association of Certified Marine Surveyors//ACMS-USA.COM
Check us out on the web at www.jimcross.net

August 31, 2010

Re: 1962 33 Herreshoff "Meadowlark" Sharpie "Lady Hamilton"

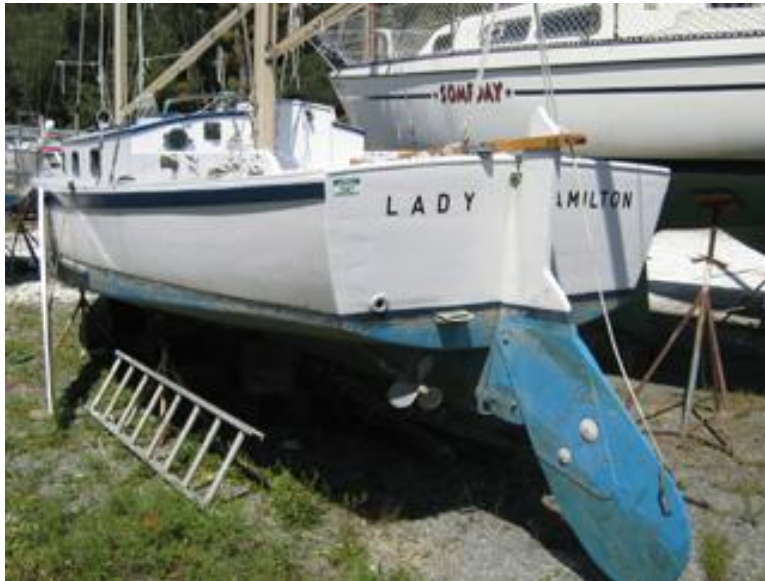
The hull is a wood structure of one and one eighth inch thick Long Leaf Yellow Pine planking. The fasteners are bronze screws and bolts. The frames and main timbers are sawn white oak 15 to 16 inches on center. The coach top and decks are of White Cedar. The same construction technique is applied in all areas. The hull design and

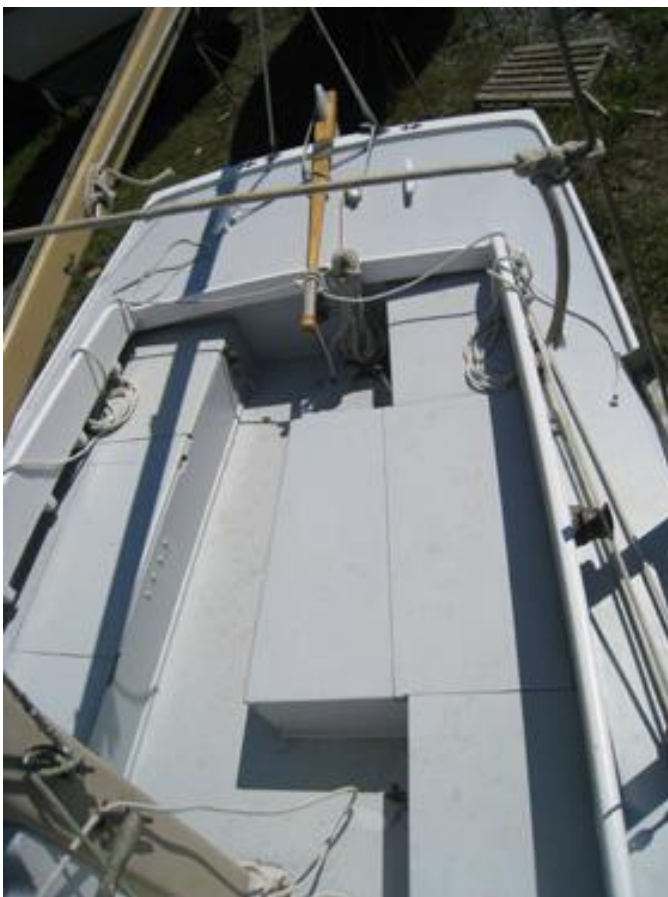
hull is seaworthy, for a vessel of this age, all frames and planks must be examined. The interior of this hull permits such an inspection with ease, due to the spaciousness of the area below deck. The planking shows no softness or rot, and the only leak I could detect was coming from the packing at the stuffing box. I did not detect any frames that are showing signs of rot. The exterior of the below the waterline section of the hull was inspected and it is fair and in good condition. From an outside vantage point the planking and hardware are in very good condition. Another element that must be considered to determine the seaworthiness of this vessel is the frame and sole support fastening system. Typically, a few random fasteners are removed during inspection. These fasteners should be checked for corrosion. The fasteners of concern (in the deck makeup), were examined and found to be in good condition. The keel makeup and floor timbers are in good shape, as are the engine beds. (The engine beds appear to be fairly

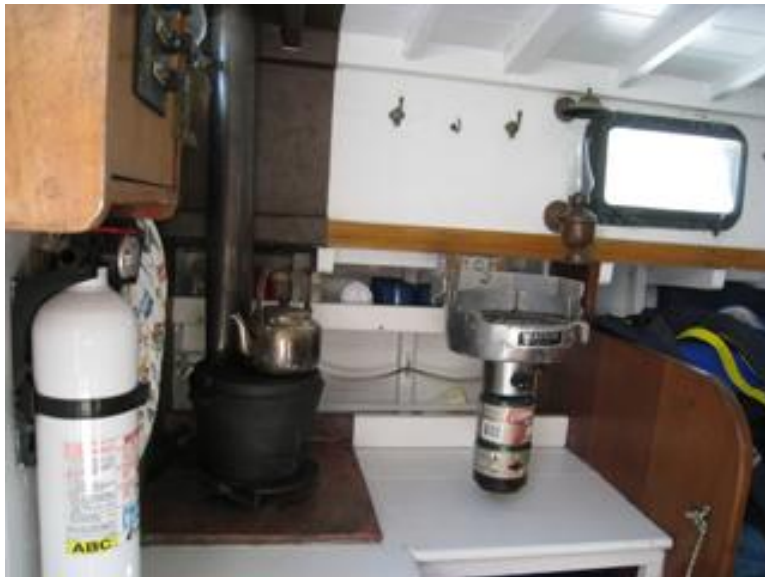
Four good size berths are located in the main cabin. This area is clean, nicely finished and upholstered. There is adequate lighting and ventilation in this area. The sole in this area is properly supported, nicely finished and in overall good condition. The jointer work is pine and mahogany. I was unable to locate any excess moisture on any surface in this area. The overhead is painted and in good condition, with no fresh water stains.

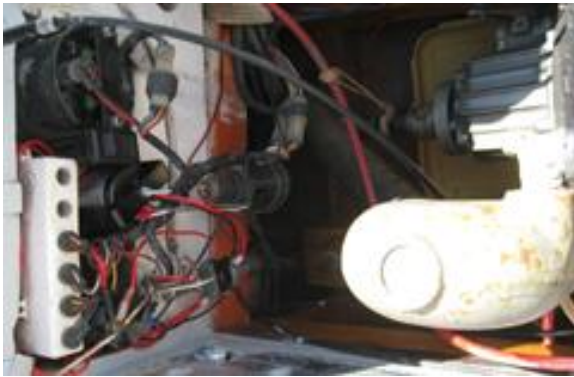
The engine and gears are in good condition, very clean and appear well maintained. Ventilation to the engine spaces is adequate. The exhaust system is cast and rubber, heavy duty, and in good condition as much of it has been upgraded during the past two years. The system clamps are not all doubled. All through hull fittings including the valves are bronze and in working condition.

Recommendations: Double clamp all engine cooling hoses which connect to overboard.

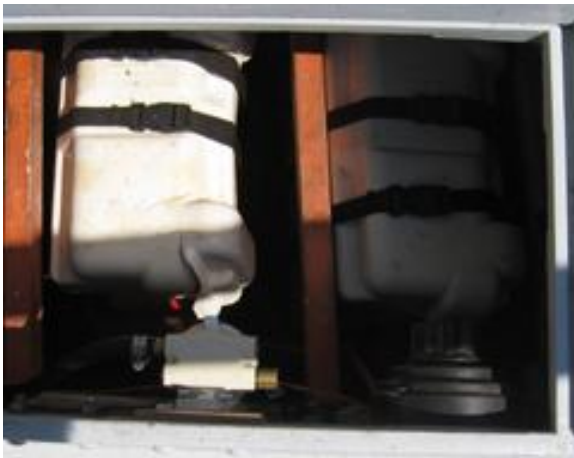
The batteries are good condition and properly connected to the approved three way switches and then on to custom fuse panels. The batteries are properly boxed and covered. The wiring and terminals that could be observed are in good condition. The electrical wiring is in good shape and properly harnessed. The automatic battery charger was not checked out. The navigation equipment and electronics, was not checked out.
