April 5, 2011

Re 2003 Silverton 42 Convertible "JO DEE"

This letter reports the results of a survey of the above vessel which was inspected on the 5th of April 2011 while hauled and winterized, at Pilots Point Marina in Westbrook Center, Connecticut. You requested the inspection to establish its condition and value.

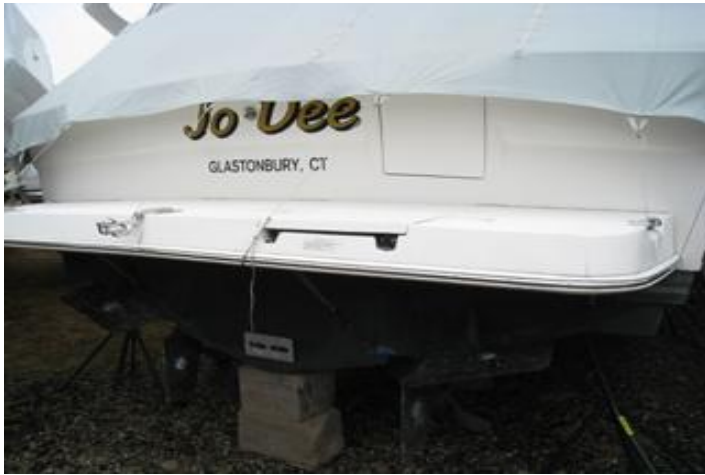
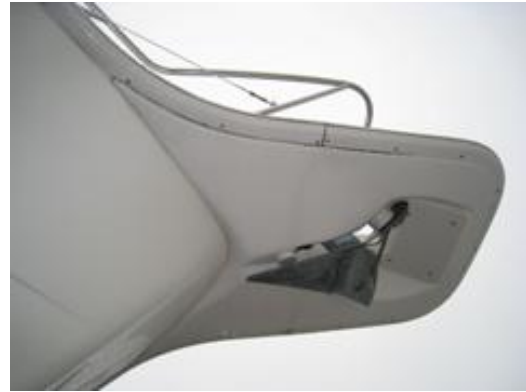
The hull is a typical polyester laminate reinforced with fiberglass matt and woven roving in a modified- Deep V configuration. The finish is white gelcoat with stainless, and aluminum trim. The finish is in good condition, overall, with only a few very minor scratches. The boot is in good condition. The bottom was sounded and is free from delamination. The topsides are also original white gelcoat and in good condition. There are good quality stainless steel and fiberglass bow and anchor pulpits properly installed. These units are in good condition, backed, and secure. The hull - deck attachment is secure and reinforced by the stainless and rubber rub rail. I was unable to locate any delamination or separating of glass, including the engine bearers and stringers. The bulkheads are properly tabbed and rigid. All through hulls (majors are bronze and minors are plastic) are in good condition, and their related valves are working properly. There are adequate large chrome plated bronze cleats provided for docking. The cleats are secure and properly backed. The vessel is equipped with a large fiberglass swim platform. The platform is properly supported by stainless steel brackets attached to the transom. The overall integrity of the platform and supporting components is good. The boarding ladder is secure. The propeller shaft logs are good condition. The forward deck was checked for soft spots and moisture infiltration to the core material. The deck is secure and free from any core moisture. An electric anchor windlass is properly installed.

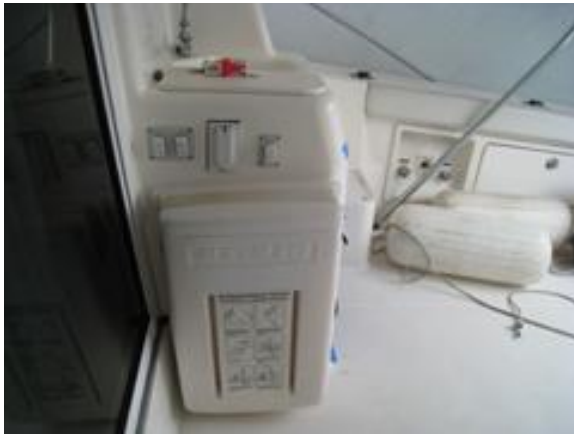
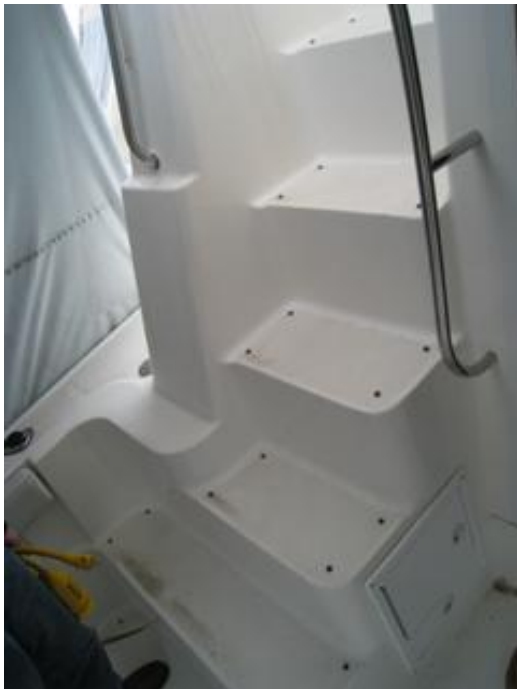
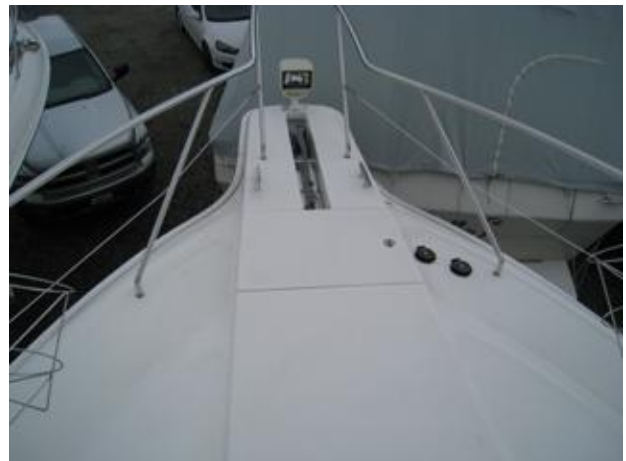
Access to mechanical and fish spaces is gained through a hatches in the deck of the cockpit. The deck has been well maintained and is properly supported, and is in good condition. The cockpit area is in good condition and the gel coated surfaces are free from major damage. The entire cockpit and forward deck was checked for excess laminate moisture and none was noted. All deck hatches are equipped with twist locks and are in good shape and secure. The fittings for the electrical and water shore power appear lightly used. All rails and cleats are in good shape. Overall, the condition of the outside surfaces is lightly used and in good condition. A wet bar with attached Life Sling is located in the cockpit area. The canvas cockpit cover is in good shape. The ladders, (moulded in) to the bridge is a great feature.

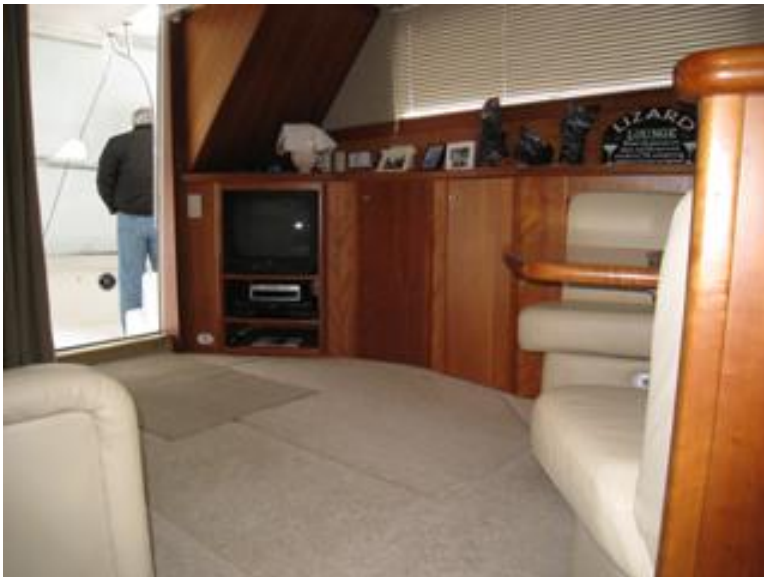
The main cabin houses the salon-dinette and galley. The berths and heads are forward and below. This area is spacious, nicely finished and in very good to excellent condition. The entire area is carpeted with a plush, color keyed, mold resistant nylon material. The carpet is protected with a nylon liner. The vinyl headliner is clean, in very good condition and secure. The upholstered sections, bulkheads, and joiner work show light use, very good care and maintenance. The interior joiner (other than the liner) work is plywood with a veneer and is has a very well maintained finish. The main salon is equipped with heat and air conditioning. Custom blinds, curtains and draps. lockers and storage space is adequate. Hatches and ports are tight to the weather and secure.

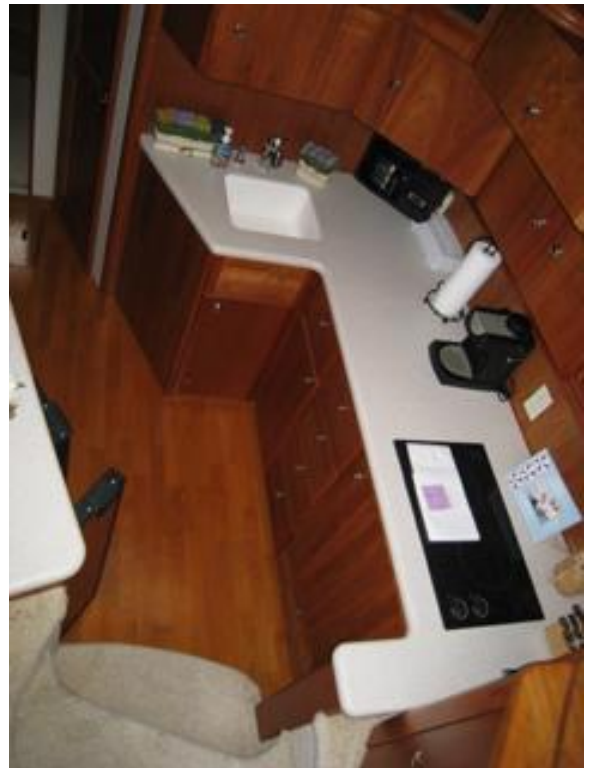
The electric stove and refrigerator appear in good condition, but were not tested (no power or water). The moulded counter top in the galley is in good shape. There is a large sink moulded into the counter-top. The sink and its related faucets and over board drain are in good condition. The sole in the galley area is hard wood and in very good shape.

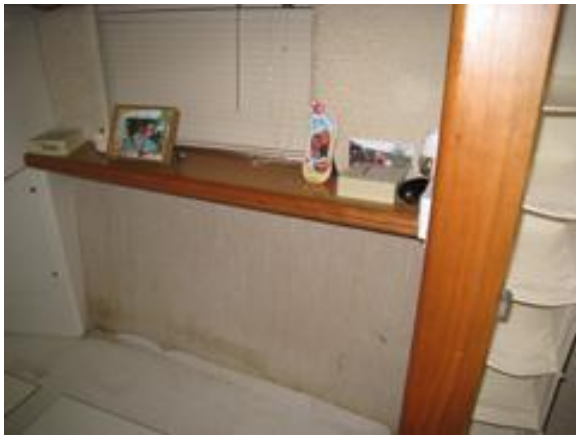
The crew's berth areas (aft of the forward berth and pictured at left) will sleep two, and are in about the same good condition as the forward berth. The upholstery is off for winter and the mattresses are in good, clean condition.

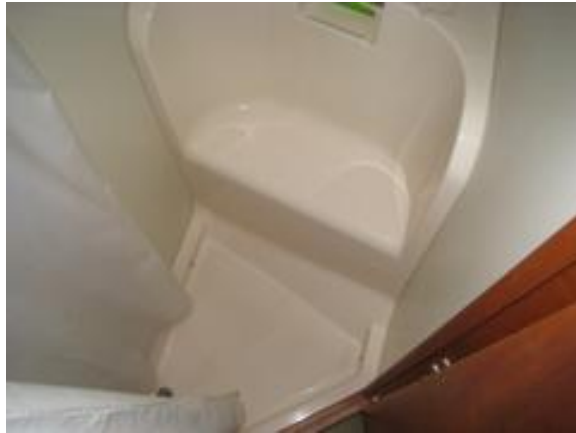
There are two separate compartments for the head and shower, both in very good condition. They are equipped with a standard electric marine toilet, shower and hand basin. The shower unit is an integral part of the inner liner. The shower drain into a sump and then pumped overboard. From the appearance of the plumbing, carpet, and other fixtures, including the galley gear this vessel has been lightly used, and certainly not abused. A plastic holding tank and related Y valve and plumbing are included. The hot and cold fresh water system looks good, but was not checked out.

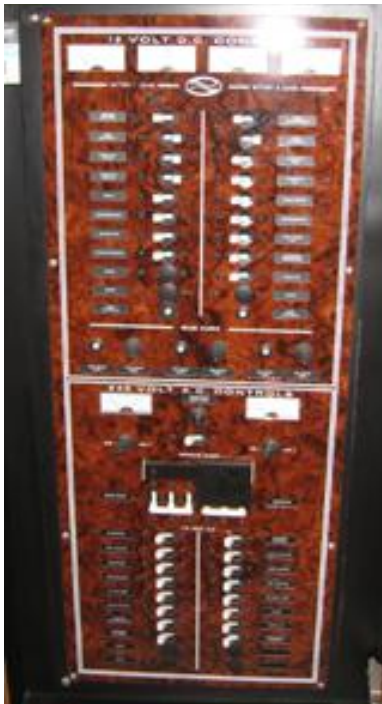
The combination AC/DC and AC generator power panel is mounted in the main salon and is easily accessible. The breakers and circuits were found to be in good condition. All circuits were checked out and found to be in good operating condition. A satisfactory (factory installed) ground system is employed. Appropriate Ground Fault receptacles are installed in the galley and head. The depth finder and Standard VHF transceiver are in good working condition. There are battery disconnect switches mounted on a frame in the main salon, and they are in good condition and secure. The navigation lights conform to the CFR and ring out okay.

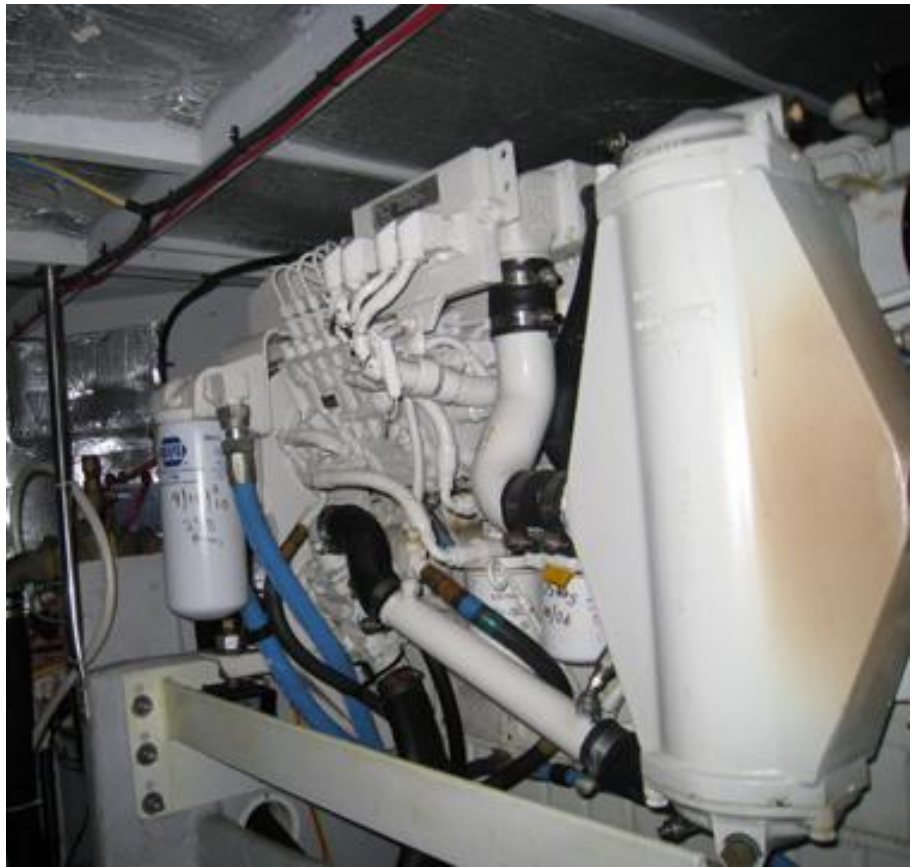
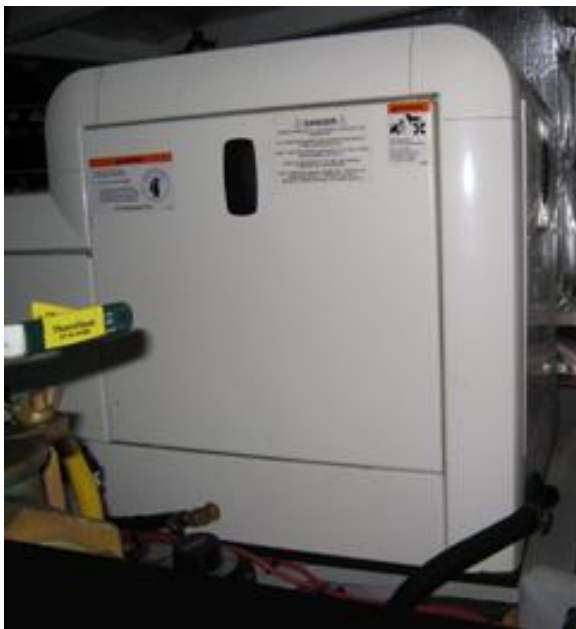
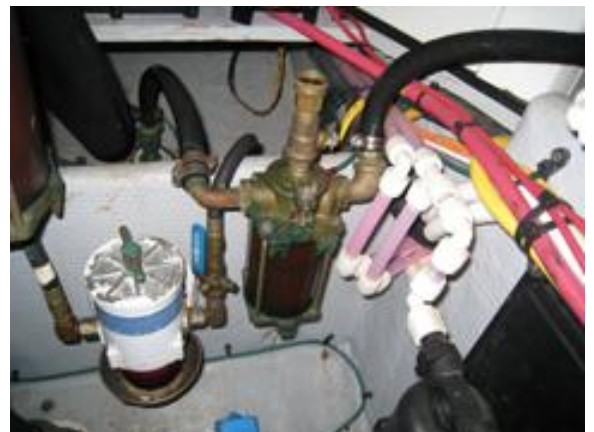
Propulsion is by a pair of fresh water cooled counter rotating Turbo charged Cummins Diesel engines with reduction gears. Approximately 485 HP each. The stainless steel shafts and water cooled shaft logs are in good shape. The rudder shafts and shaft logs appear in good shape. Visual inspection of the engines, oil, filters, coolant, and related connections show that a good maintenance regime is in effect. Approved bilge blowers and hoses are installed and working. There are two bilge pumps mounted in the bilge, and functioning. The fuel tanks are in good condition, as can be inspected. There are proper fuel shut-off

valves on both feed lines. Shut-offs are in good working order. All fuel lines and valves are in good condition. Electric/hydraulic trim tabs are sized and installed. There is no trace of oil in the bilge, and the bilge is clean overall. The exhaust systems including large fiberglass silencers is also in good condition. All bronze valves and salt water devices in the engine compartment are in good condition and properly bonded. The AC generator was not checked out while running, it does appear lightly used. The intake and exhaust systems, including the fiberglass silencers and sea water strainers on all three

engines are in very good condition.
