Re: 1995 40' Tiara Model 4000 Open Express "BAD BOY"

This letter reports the results of a survey of the above vessel which was inspected while hauled on the 31st of May, 2011, at your property in North Dartmouth, Massachusetts. You requested the inspection to establish its condition and value.

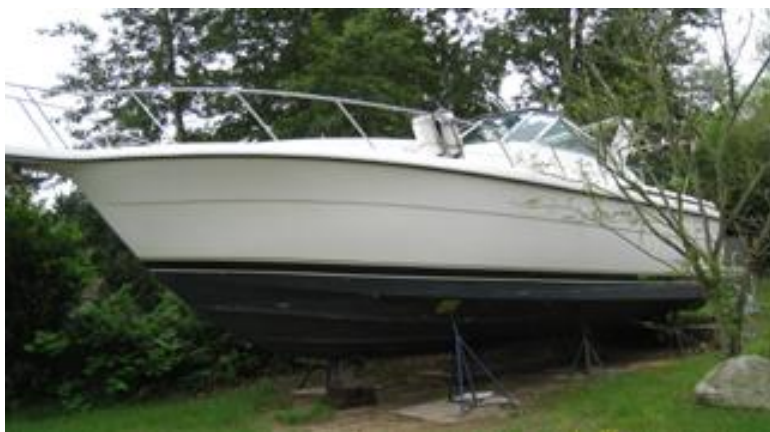
The hull is a heavily laid-up polyester laminate reinforced with fiberglass matt and roving in a modified deep vee configuration. The hull and fiberglass structures were laid-up by hand. The hull below the waterline is solid fiberglass. The fore deck and cockpit deck are constructed of solid fiberglass with reinforcing. The structural integrity of the hull is good. The bulkheads and interior tabbing are in good condition and secure. All bulkheads are marine grade Mahogany or Teak plywood. All stringers and frames are mahogany. The hull is much more rigid, (because of its extra thickness), than similar contemporary hulls. The

finish is the original white gelcoat. The finish is in excellent condition, overall, with only a few superficial mars and scratches. There are no structural abrasions on the freeboard part of the hull. The hull-deck attachment is secure and trimmed with a stainless steel rub rail. I was unable to locate any delamination or separating of glass, including the aluminum engine bearers and stringers. The bulkheads are properly tabbed and rigid. The interior sur-

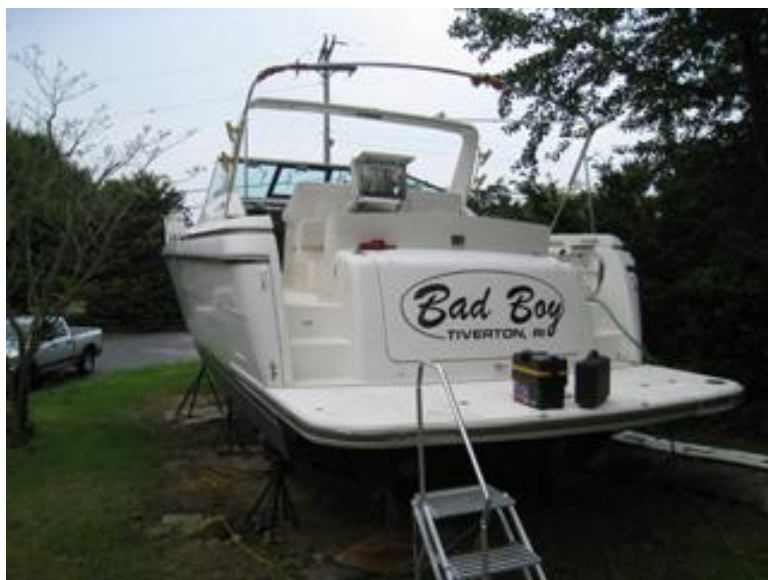
The bottom (sections below the water line) was also in very good clean condition. The anti fouling coating has been applied and there is no trace of blistering or crazing. All through hulls below the boot are silicone bronze and in good condition, and their related valves are working properly. The valves have been cleaned and serviced. There are adequate large chrome plated bronze cleats provided for docking. The cleats are secure and properly backed. The ladder to the huge swim platform is in good condition and secure. The fiberglass radar arch is in good shape and properly secured. The after market swim platform is well supported and secure. The bonding (ground) system is properly in-

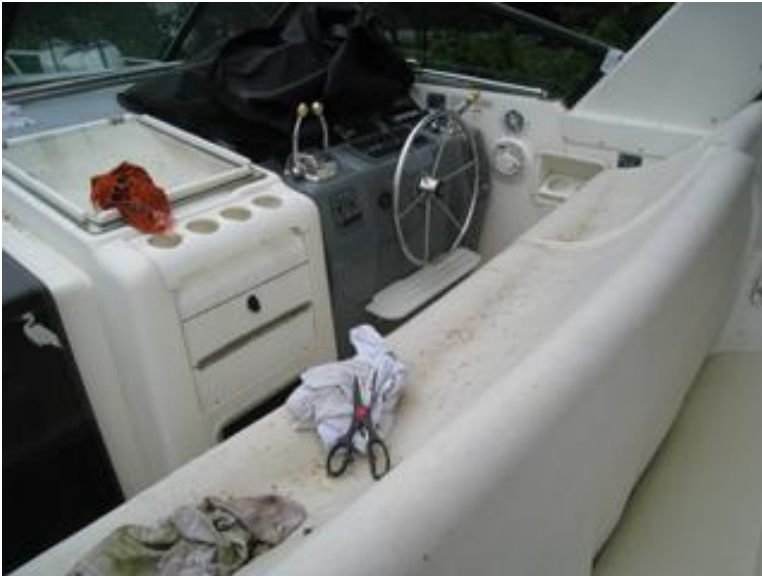
Operating Station

The operating station is well designed and the controls are easy to operate. The cockpit area, including the upholstery, is in very good condition. The gel coat has only minor crazing and season cracks. The vinyl upholstery shows no signs of abuse. The Ritchie compass is accurate on the present bearing. The throttles and shifts are smooth operating. The control cable were replaced with new hardware in 2006. The stainless steel wheel operate smoothly. The control panel, including gauges, is in good condition and secure. There is a

tinted multipart windshield installed and the operating station is covered by a fairly new canvas enclosure. Access to the engine spaces is gained through hatches in the deck of the cockpit area. All deck hatches are in good condition.

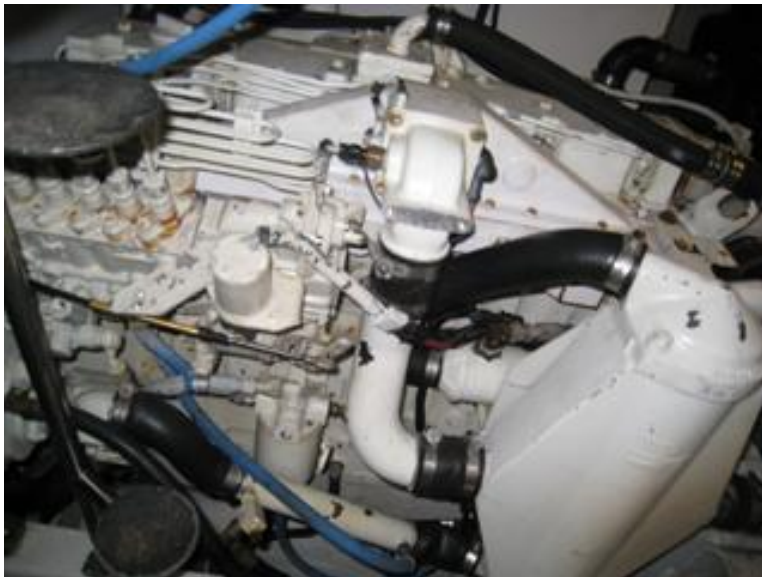
Engine and engine spaces

Propulsion is by a pair of water cooled counter rotating, turbo charged 450 HP Cummins diesel engines with ZF Hurth Marine reduction gears. The engines and gears (one shown) appear well maintained. The upgrade installation was carried out in 2006 by the yard and is certainly a professional installation. While the engines and generator were out the entire engine compartment was cleaned and a white Epoxy coating was applied to all surfaces. New sound deadening insulation has just been applied to all appropriate

surfaces. Ventilation to the engine spaces (natural and via twin bilge blower) is adequate. The exhaust system, Approved rubber to fiberglass silencers, is of the approved type and properly secured. All mechanical and electrical equipment, including all wiring is receiving proper maintenance and is in excellent condition. There is a bilge pump installed and working in this area. The rudder shaft logs are in good condition. The new water cooled engine shaft logs are secure. A fresh water cooled 9 KW Onan Diesel powered generator was also installed in 2006 and remains in good secure condition. The exhaust system including the Onan silencer is also in good condition. The appearance of the engine compartment is that of a well maintained vessel.

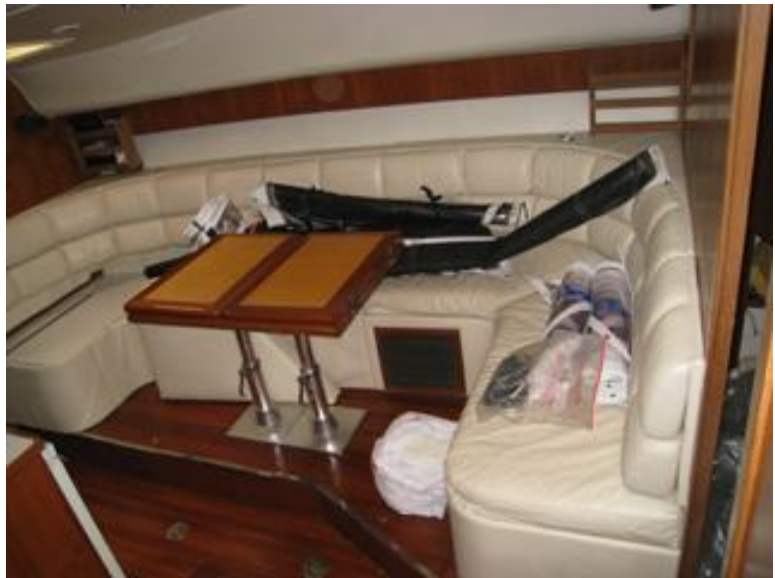
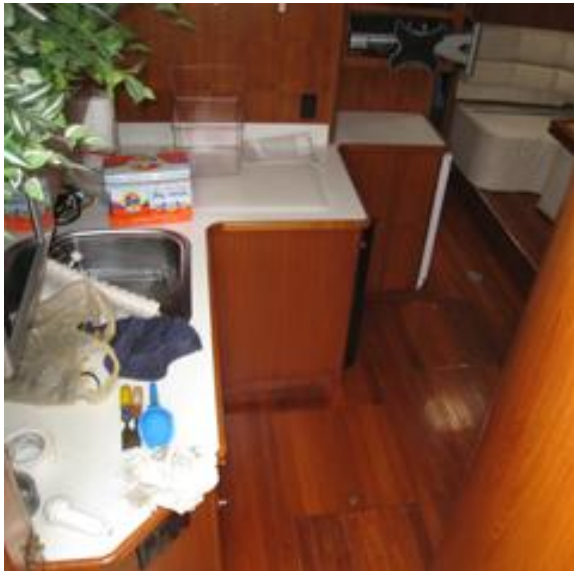
The forward berth is located beneath the forward deck. This area will sleep two. This area is clean, nicely finished and upholstered. There is adequate lighting and ventilation in this area. Also, housed in this forward berth area are several PFD's, several lockers and rode storage. The bilge in this area is clean. The main cabin houses the

salon, galley and two heads. The interior is large, nicely finished in Mahogany, Formica, and Teak. The jointer work has been well maintained and is in very good condition. No rot was detected at any location.

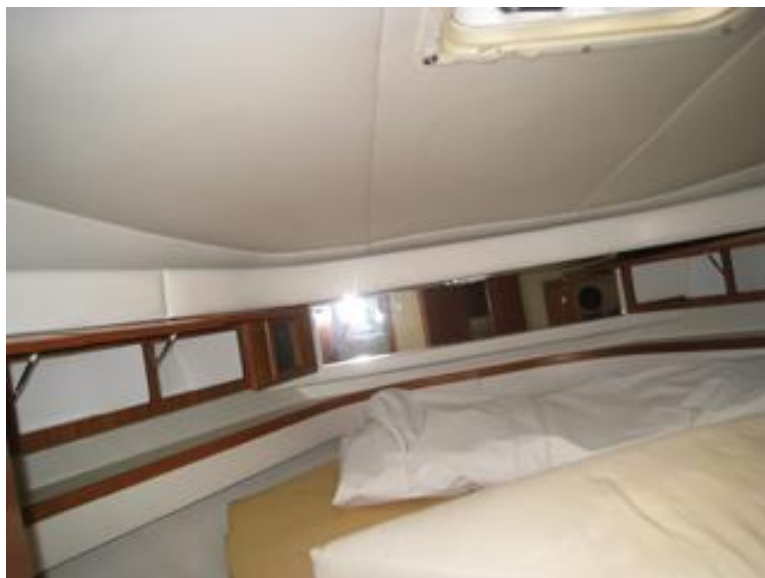
This area was checked for excess moisture content in all partitions, the overhead, and all fiberglass surfaces. All checked out fine. The Teak and Holly sole is well supported and is brightly finished. There is no delamination of Formica. The stove and reefer system appear in good condition. The reefer

units are custom built and in working condition. The double stainless sink and hardware are in good condition. The upholstered sections are in good condition and show only light use. The stove and microwave system appear to be in very good condition. Lighting is good throughout the vessel. The dinette converts to sleep two. The head liner is in good shape. The main cabin, overall, is in excellent condition.

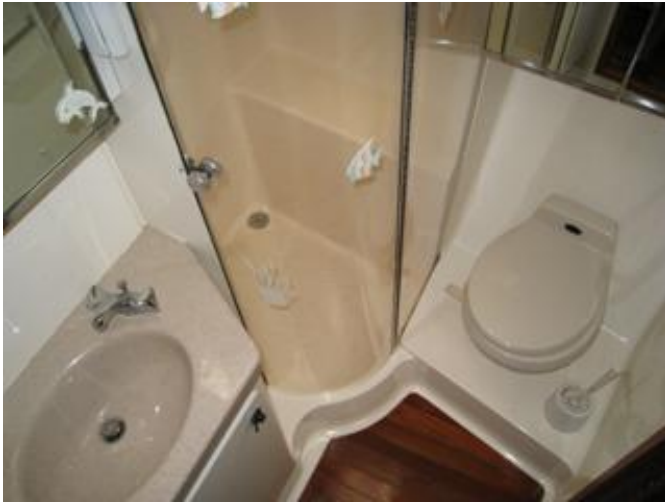
Two heads with one shower

There are two heads located in this forward area. The toilet, enclosed shower with hot and cold pressure water, hand basin, and their discharges and through hulls, are in good condition. The heads are clean and well kept.

The larger forward head is a multi piece laminate enclosure. It is properly secured to the hull and forms an integral part of the hull unit. It houses a vanity with hand basin, marine toilet and shower. It is in good condition. There is a macerator unit installed. This unit was not checked out. Dockside pump out was not checked out. There were no

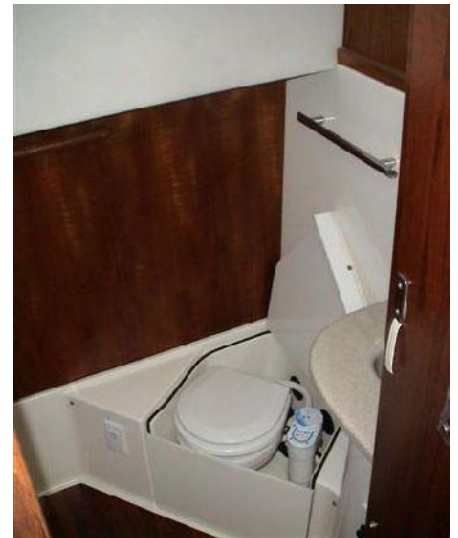
The aft head is also a multi piece laminate enclosure with no shower. It is properly secured to the hull and forms an integral part of the hull unit. It houses a vanity with hand basin and marine toilet. It is in good condition. There is a macerator unit installed. This unit is functional and in good condition. Dockside pump out was not checked out. The overall condition of this aft area is good and is in the same condition as the forward areas.

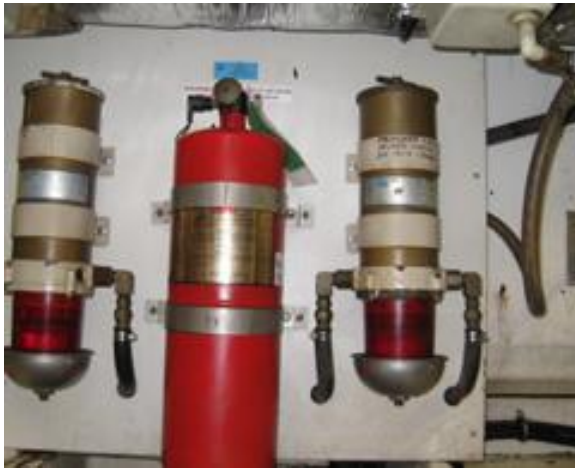
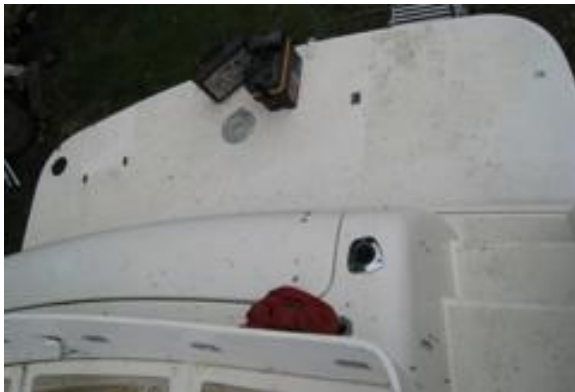
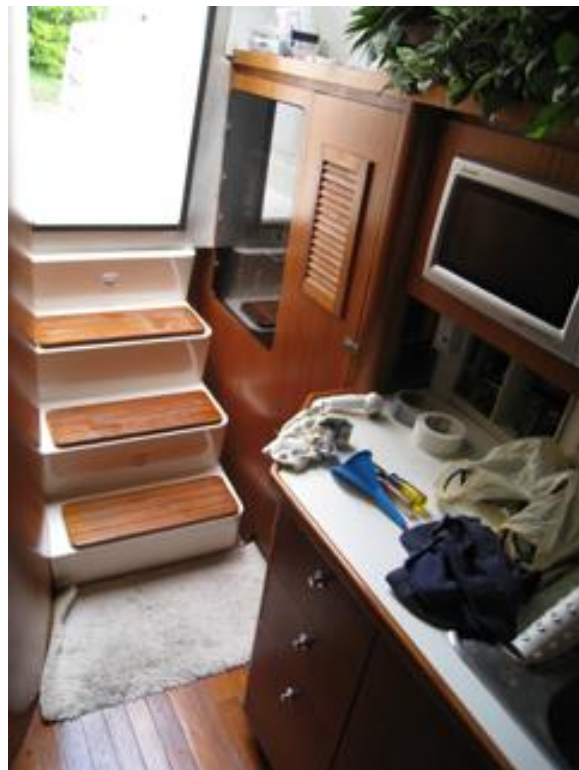
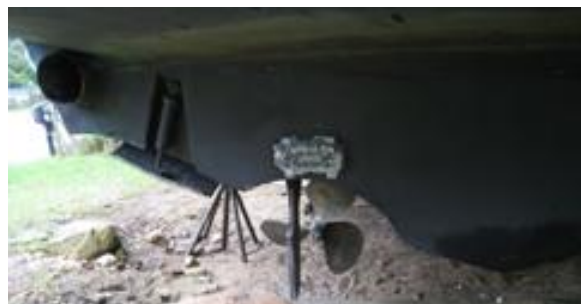
There are three aluminum 120 gallon tanks properly mounted (strapped) just aft of the engines. The fuel shut-offs (at the operating station) are in good order. The fuel fillers (Racor) are properly installed. The fills and copper fuel lines are in good condition, as are the flex lines to the engines. The water heater is properly secured to outboard of the port engine. A 42 gallon PVC holding tank is properly installed and in good condition. No septic odor was noted. The Y-gate checks out fine.
