JAMES CROSS, Certified Marine Surveyor

Re: Steel Fishing Vessel

This letter reports the results of an audio gauge of the bottom plates only. No welds or seems were checked. The audio gauging was conducted on Saturday, June 13th at the providence Shipyard in Providence, Rhode Island.

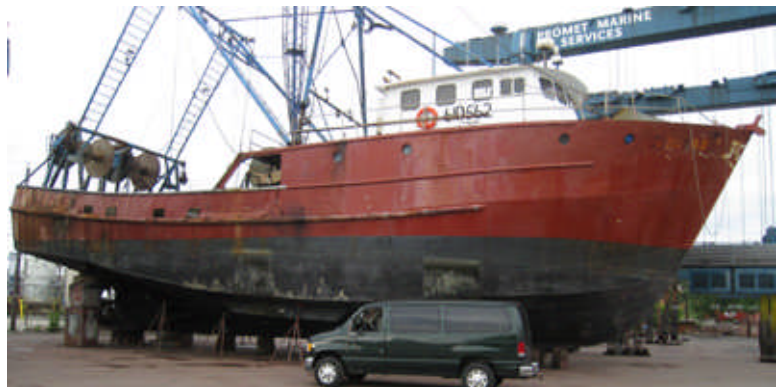
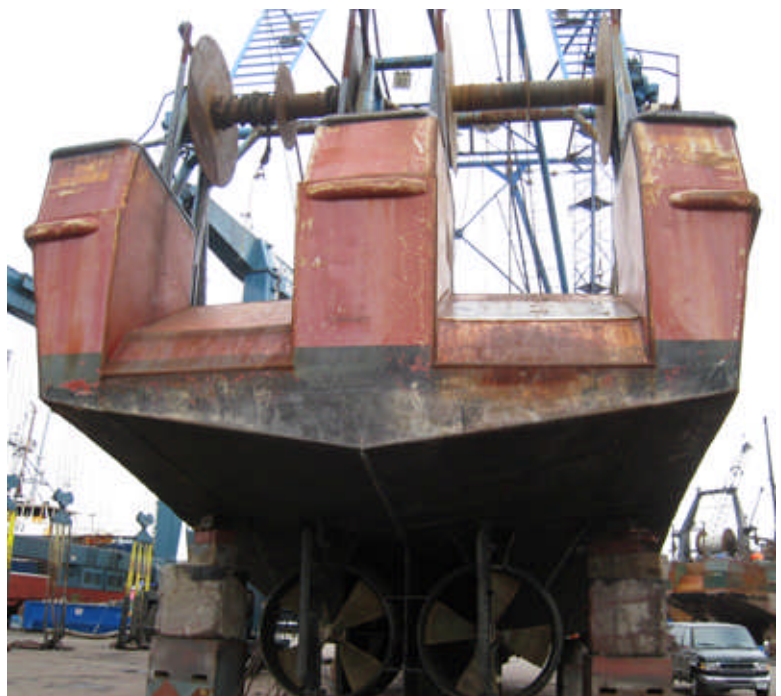
As no name was visible these photos are included for identification purposes, only.

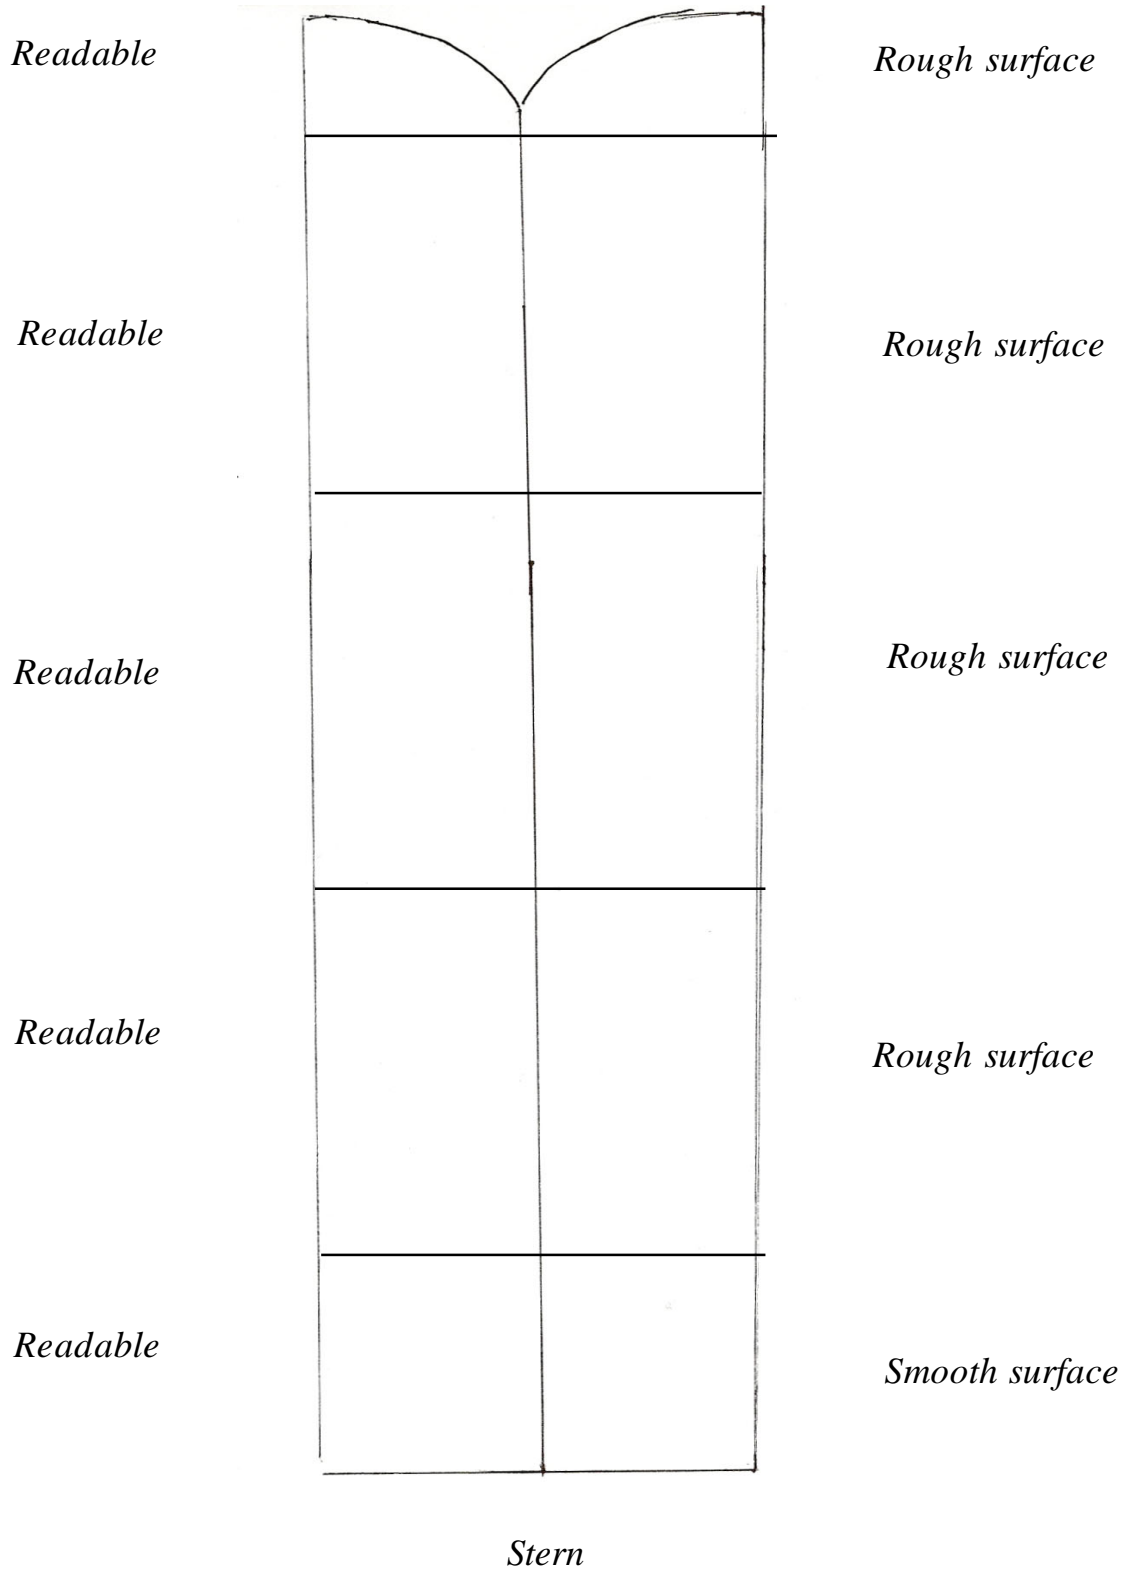
Basic Layout, Readable or Non Readable, Rough surface, Bottom only

Vessel plate surface condition, Bottom only

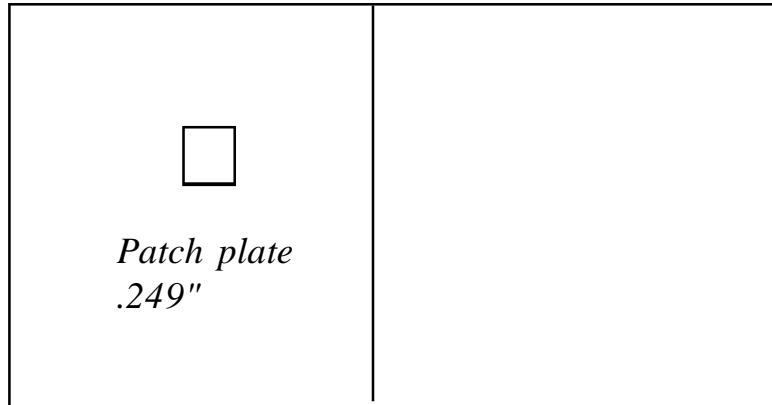
Fantail, Recently added plates

*Star Side
Average thickness .362"*

*Port Side
Average thickness .366"*

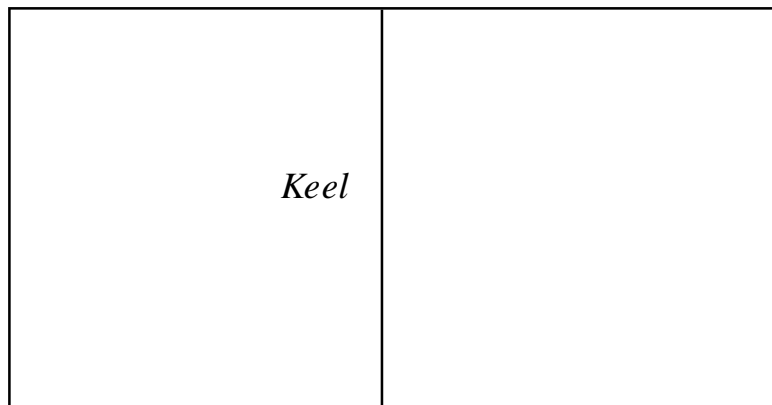
Bow section, Reinforced

*Star Side
Average thickness .344"*

*Port Side
Average thickness .341"*

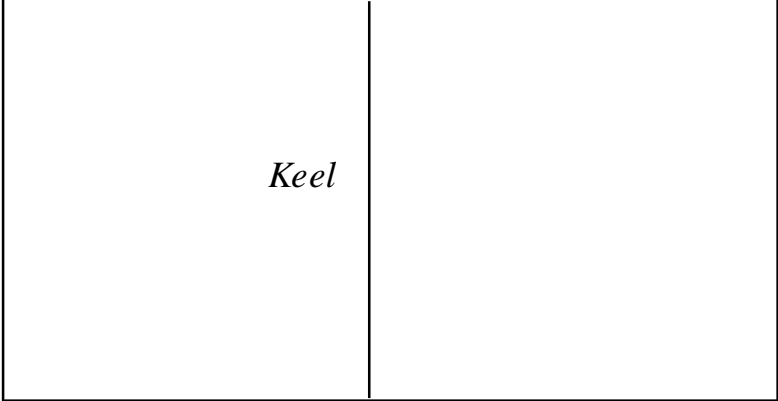
From Bow reinforced section aft to stabilizer planes

*Star Side
Average thickness .362"*

*Port Side
Average thickness .375"*

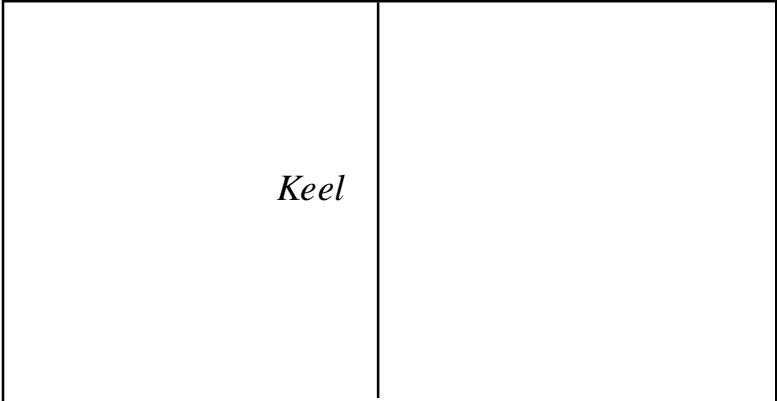
Amidships from stabilizer to aft

*Star Side
Average thickness .344"*

*Port Side
Average thickness .341"*
