**JAMES CROSS**, Certified Marine Surveyor

June 12, 2013

Re: 2008 Jupiter 38 Forward Seating

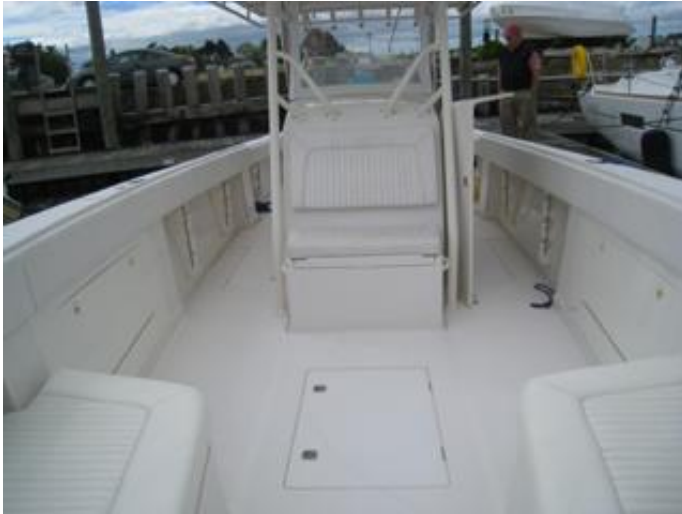
## Hull and Structures

The hull is a polyester laminate reinforced with fiberglass mat and woven roving in a modified deep V configuration. The exterior laminates are Vinyl-ester. Four-piece construction with foam-filled fiberglass grid stringer system Single skin, non-cored fiberglass hull, stringer system, cockpit liner and deck

Hull, stringer system and cockpit liner are chemically unit-bonded. The non skid fiberglass cockpit liner with large through-transom scuppers, through-bolted 316 stainless steel hardware is in good

shape. Stainless steel through-hull fittings above the waterline and Bronze through-hull fittings below the waterline. High density composite transom encased in fiberglass and bonded to the fiberglass stringer system. The gel coat is off white and white, and in very good condition. The forward deck seating and related and hatches are in good condition. There is an inner liner throughout the vessel which comprises the view of the interior and this gel coated fiberglass liner is also in good condition. It is obvious that this vessel has had no abuse. The spaces, compartments, and voids, between the hull and inner liner are epoxy coated. These areas could use cleaning, but are in good structural condition. The topsides are white, and in good condition free of major mars and scratches. The windshield and supporting structures are in good shape. The steering apparatus is in good condition. All of the rails and cleats are

properly secured and constructed of stainless. The navigation lights comply with CFR regulations.

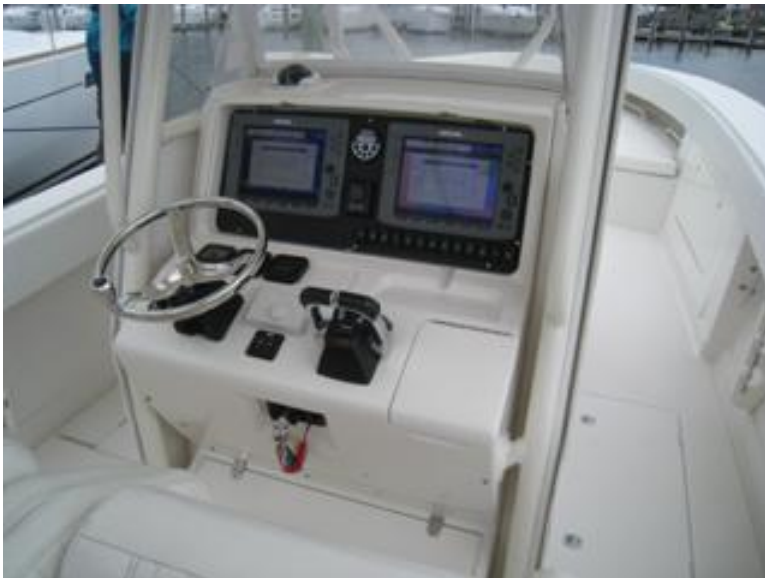
## Cockpit and Operating Station

The cockpit is equipped with a canvas top and enclosure. The supporting structure and top are in good condition. The structure is properly backed at the attachment points. The wheel, gauges and controls are in good shape. The cockpit area is clean and the finish is in unusually good condition. The vinyl upholstery, including the bolstering, is also in good condition. The control panel and

switches appear in lightly used condition. The fuel fill is properly installed and marked. There are a variety of wells and lockers built in fore and aft, all are in good condition. Access to the battery switches is gained in the head.

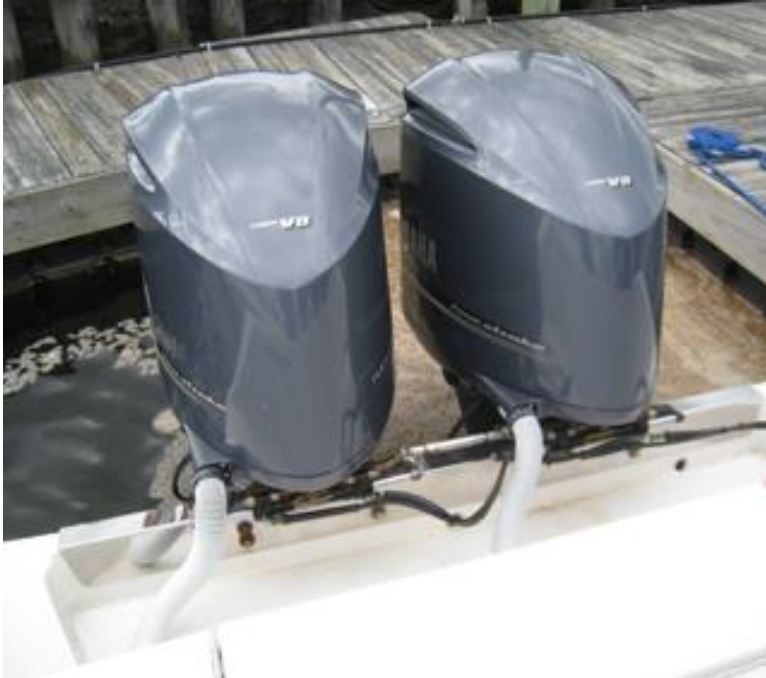
Propulsion is by two 350 hp Salt Water series Yamaha outboard engines. Both engines started and ran with no hesitation. Visual inspection of the engines, and related connections show no signs of abuse. Visual inspection of the lower units indicate no grounding or abuse of any consequence.

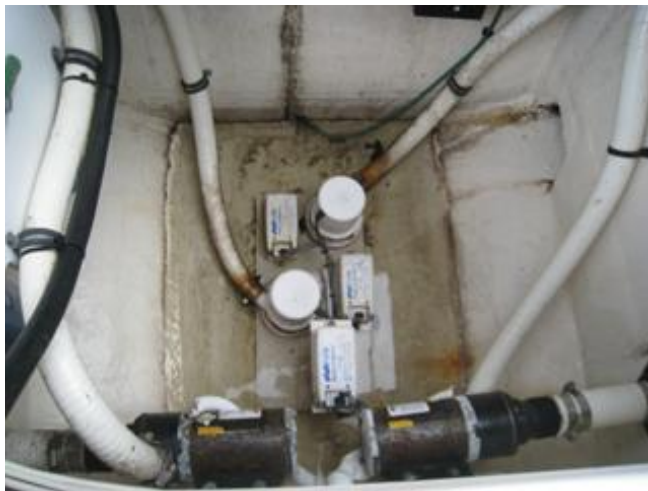
There are three bilge pumps mounted and properly functioning. The fuel tanks can not be completely inspected. They do appear properly secured and grounded, as are the related fills and vents. There is

no fuel shut-off valve on the feed line. The overall appearance of the below deck mechanical space is good.

The aft gear compartment is also in need of cleaning, odor free, and free of any unessential material. It houses, among other devices, the various pumps and bilge pumps. The batteries are properly installed and secured. The battery connections are appropriate as are the cables. The electrical wiring and terminals observed throughout the vessel are in good condition. The throttle and gear linkages are in good order and work smoothly.

Recommendations: Install backup ground tackle, insure that a complete Coast Guard Safety and Signalling package is aboard. Install appropriate AC hardware and circuit protection. Clean bilges. Repair cockpit entry door latch. Batteries may be original, expect to replace in near future.

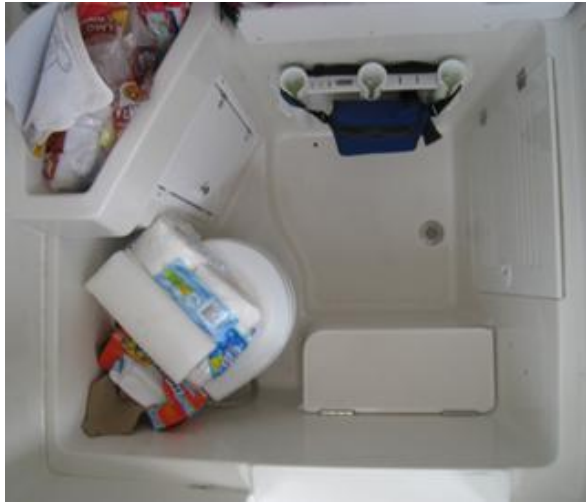
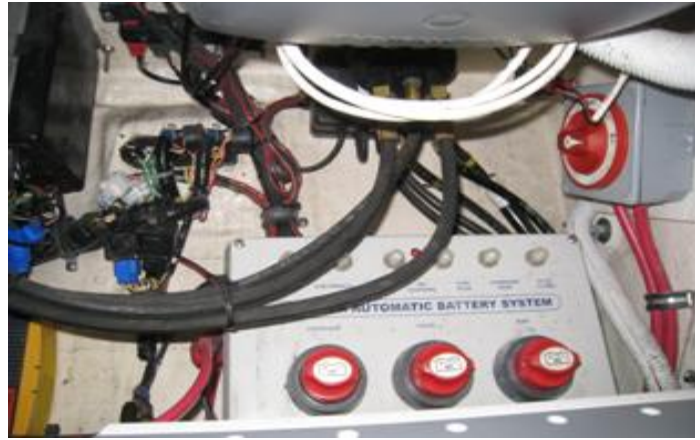
The head is a fiberglass enclosure. It is interior of the center console. It is properly secured to the hull and forms an integral part of the hull unit. It houses a standard electric flush marine toilet. It is in good physical condition and clean. There is a macerator unit, and holding tank. These units are in functional condition. No odors were noted around the septic system.
