JAMES CROSS, Certified Marine Surveyor

Re: 1981 Bristol 455 Sloop "PANDORA"

This letter is an update of a survey performed by me on this vessel in February of 2010. During the past year this vessel has undergone a complete professional refit. Page eight and nine detail the exact refit. Page ten, a Photos page, will validate much of the work as it proceeded along to completion. The final results of the inspection indicate a professional work ethic with little regard for expense. The final inspection took place on the 16th of August, 2011 while afloat at Brewers Cove Haven Marina in Barrington, Rhode Island. You requested the inspection to establish its condition and value as you intend to increase the insurable value.

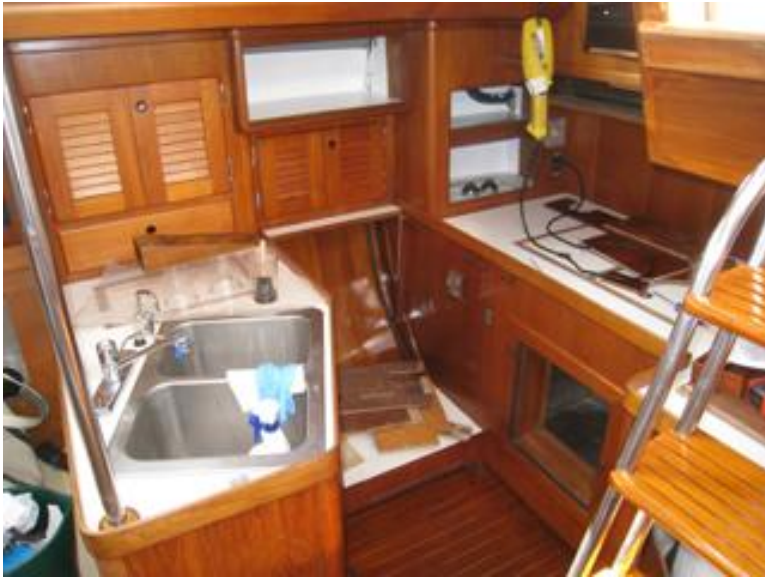
Closets, lockers and other storage areas are more than adequate through out the vessel. The built in reefer and stainless steel sinks are in good condition. There is a pressure hot and cold water system installed. The potable water system was not checked out. The propane stove-oven is fed through proper lines and valves from the tanks, which are properly mounted, secured, and vented to overboard at the stern. The gimballed stove and its related hookup are proper and secure.

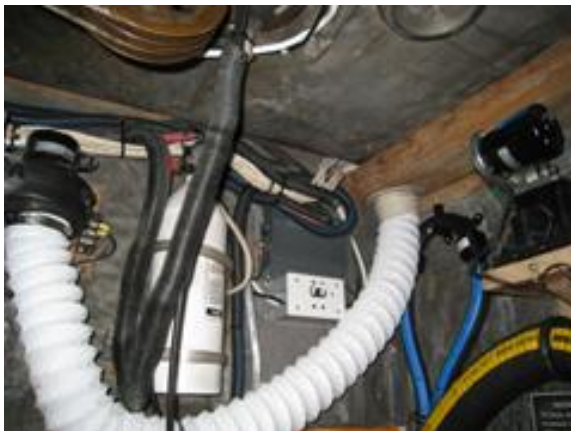
The batteries (new 8D) are properly sized, secured and boxed. The breaker panel, at the navigation station, is also in good shape. The electrical wiring and terminals observed throughout the vessel appear in good shape, but

all could not be checked out. Some of the DC circuits were checked manually and those operated. The battery three way switches are in good condition. The refrigeration system and all 120 volt systems were not checked out. Cathodic protection is installed to protect the engines and mechanical devices. A four inch thermally operated engine room blower is installed.

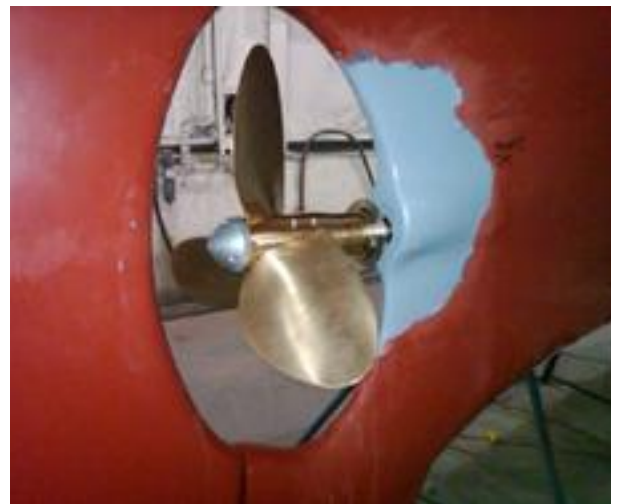
This Photos page will help to verify the extent of the re-fit of this vessel. The photos indicate fresh epoxy barrier coated bottom with new bronze through hull fittings, new sole supporting structure, new topside finish, new hull finish , new deck fittings , ans new folding three blade propeller.
