JAMES CROSS, Certified Marine Surveyor
19 Nooseneck Hill Rd, West Greenwich, RI 02817
Phone (401) 397-5040
Member Association of Certified Marine Surveyors//ACMS-USA.COM
Check us out on the web at www.jimcross.net

Re: 1991 Freedom 45 Center Cockpit

"WHITE CAPS"

This letter reports the results of an upgrade to a survey that was conducted in 2008. This vessel was reinspected while afloat on the 11th of October, 2011 at Brewer's Wickford Cove Marina, in Wickford, Rhode Island. You requested the inspection to establish its condition and value.

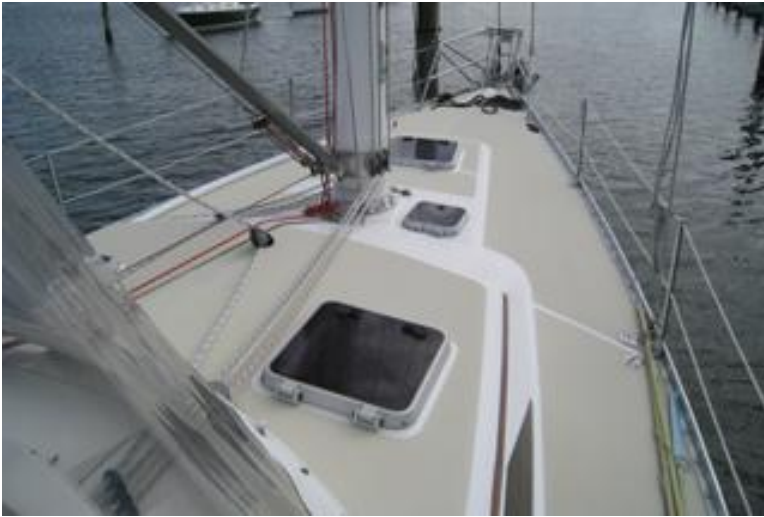
This vessel was designed and heavily built to withstand years of off shore yacht service. She is an center cockpit cruising sloop rigged for high performance and comfortable cruising.

The hull is a cored polyester laminate reinforced with fiberglass mat and woven roving. The hull is hand laid up fiberglass. The deck is similar, but with some end grain balsa core and plywood core for backing. The finish above the water line is a four year old coat of blue AwlGrip over the original gelcoat, pres-

ently waxed and clean, and has been well maintained. The hull area from the boot top to the gunwale is in excellent condition and blemish free. The hull from the boot top down was not inspected. The lead ballast is properly fitted and secure and makes up the winged keel. The keel attachment is secure.

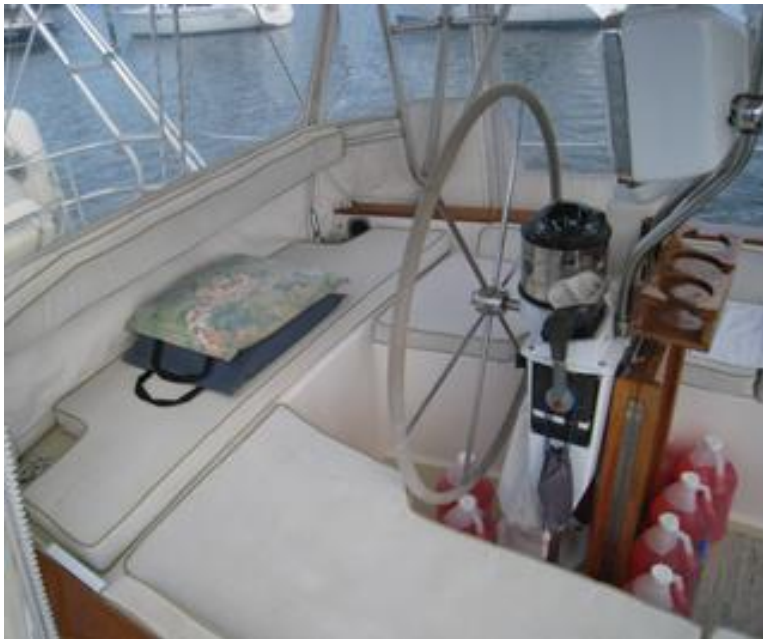
The wheel, pedestal, quadrant, cables, and all related steering gear is in excellent well maintained condition and working properly. There is a provision for an emergency tiller, and the tiller was on board.

The topsides are white gel coat with moulded in non skid, and are in good condition with a just few superficial scratches and cracks. No soft spots were noted on the deck. All outside wood surfaces and trim are teak and in very good condition. The bow and stern pulpits and life line stanchions are constructed of stainless steel and properly secured and backed. The life lines and their associated stanchions and gates are in excellent condition. The cockpit area is self bailing, through large scuppers. This area is

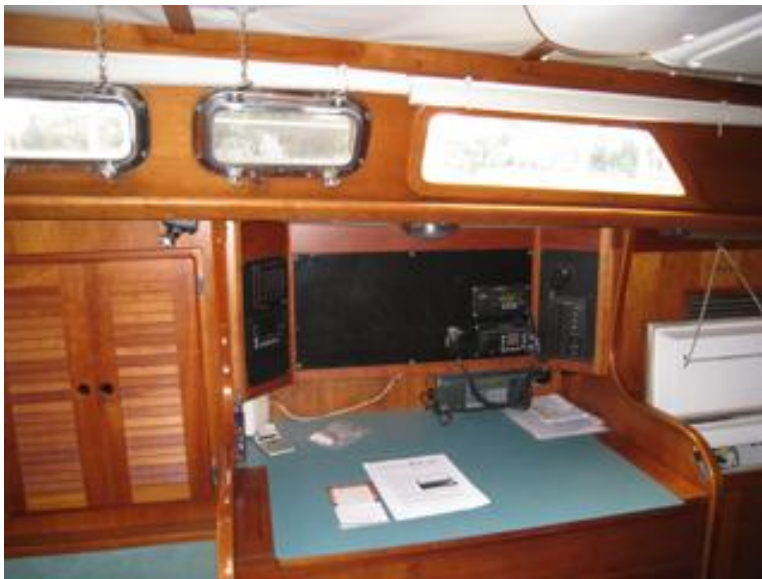
The jointer work is nicely done and in very good condition with a bright finish. The headliner is a composite of insulated vinyl with trim. The head liner is in good condition. The upholstered sections are also in excellent condition and show only light use. The sole is teak and holly over heavy marine plywood and also in excellent condition.

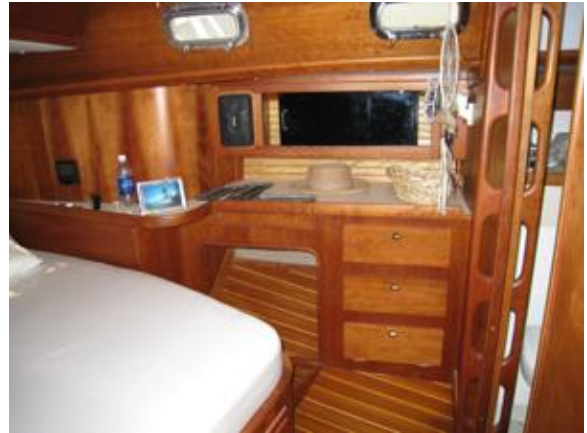
The Aft-Berth compartment is located beneath the after deck. This area will sleep two. This area is clean and nicely upholstered. There is adequate lighting and locker space in this area. The deck hatches to this area is tight to the weather and in good condition.

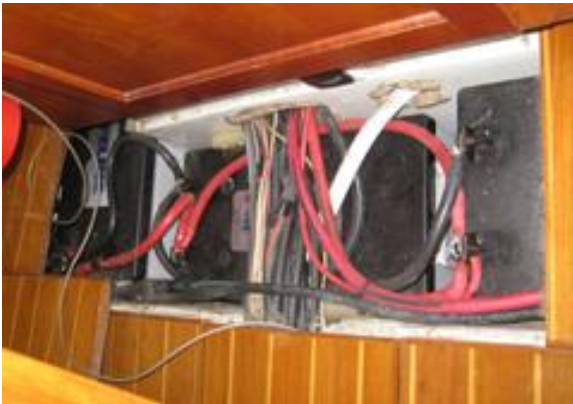
The batteries appear fairly new and are in good condition and properly connected to the approved three-way switches and then on to the custom breaker panel. The batteries are properly secured and covered below the salon sole. The wiring and terminals that could be observed are in good condition. As part of the recent upgrades, all of the electrical wiring has been properly harnessed. The shore power system overall is in good condition as are the cables. The automatic battery charger was not checked out. The navigation equipment and electronics, was checked out and all is working. The electric anchor windlass is in excellent condition and secure. The Auto pilot hardware is properly installed and appears in good condition. All of the electronics devices were checked out.
