JAMES CROSS, Certified Marine Surveyor
241 Nooseneck Hill Road, West Greenwich, RI 02817
Phone (401) 397-5040
Member Association of Certified Marine Surveyors//ACMS-USA.COM
Check us out on the web at www.jimcross.net

Re: 1996 Mainship 47 Motor Yacht "LION CREST"

This letter reports the results of a survey of the above vessel which was inspected on the 31st of March 2011 at the Oak Leaf Marina in Old Saybrook, Connecticut while afloat. You requested the inspection to establish its condition and value.

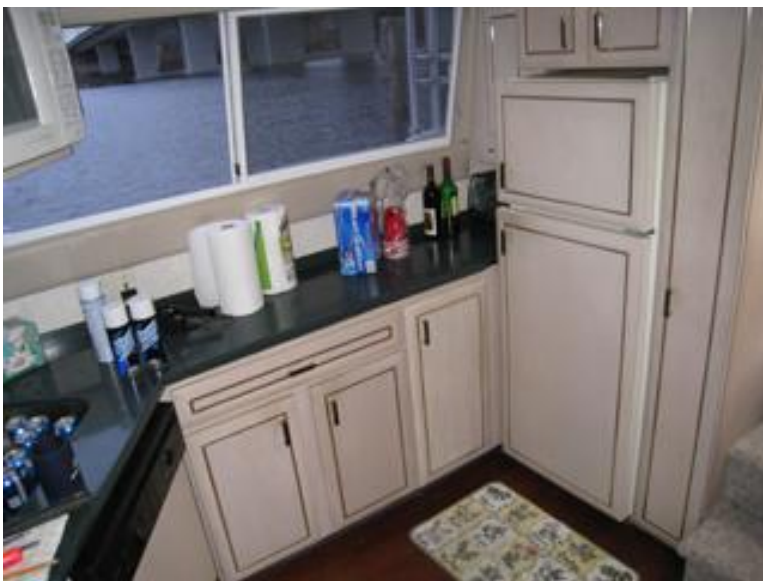
There is a complete inventory of full size galley appliances stove with oven, refrigerator, microwave oven which are in lightly used condition. The counter top in the galley is comprised of Corian which is in good shape. There is a large sink located between the stove and refrigerator in the galley area. The sink and its related faucets and over board drain are in good condition and clean. The sole in the galley and forward is also Cherry and is in excellent condition and secure. No rot was found in any deck timbers or supports. The galley is located a few steps forward and below the main salon and dinette. The galley and dinette (space for four) , overall, is in excellent condition.

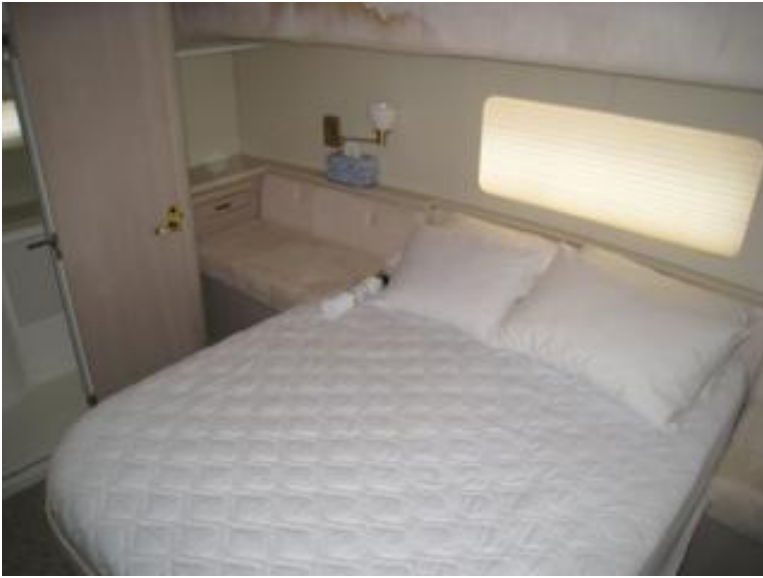
Aft berth, head, and shower

This aft berth area is not in bad shape. The area has not yet been stripped or vandalized.

The head is also a multi piece laminate enclosure with built in fiberglass shower. It is properly secured to the hull and forms an integral part of the hull unit. It houses a vanity with hand basin, marine toilet and shower. It is in good condition. There is a macerator unit installed. Functionality of the head plumbing is (all operating properly).

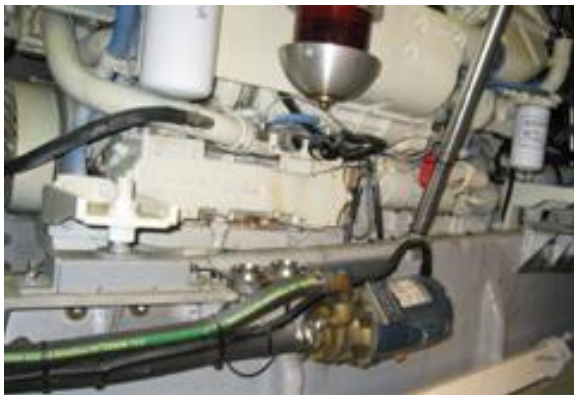
stringers that support the engine mounts are heavily built and fiberglass covered and tabbed to the hull. The stringers also provide rigidity to the hull.. The stringers are in good condition. The raw water intakes are

equipped with a proper sea water strainer, and secure. The engines exhaust through an approved rubber composite hose on to fiberglass silencers and then through the transom. The entire exhaust system is in good condition. The Westerbeke generator engine exhausts through approved rubber hose and steel silencer to overboard. The fuel lines and filters to the generator set are in good condition. The raw water intake which sup-
