JAMES CROSS, Certified Marine Surveyor
241 Nooseneck Hill Rd , West Greenwich, RI 02817
Phone (401) 397-5040
Member Association of Certified Marine Surveyors//ACMS-USA.COM
Check us out on the web at www.jimcross.net

August 31, 2010

Re: 1962 33 Herreshoff "Meadowlark" Sharpie "Lady Hamilton"

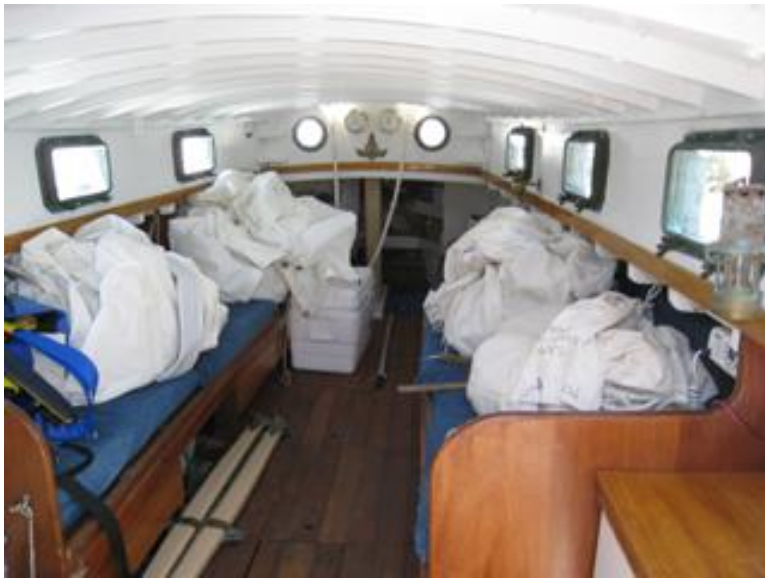
Four good size berths are located in the main cabin. This area is clean, nicely finished and upholstered. There is adequate lighting and ventilation in this area. The sole in this area is properly supported, nicely finished and in overall good condition. The jointer work is pine and mahogany. I was unable to locate any excess moisture on any surface in this area. The overhead is painted and in good condition, with no fresh water stains.
