April 5, 2011

Re 2003 Silverton 42 Convertible "JO DEE"

This letter reports the results of a survey of the above vessel which was inspected on the 5th of April 2011 while hauled and winterized, at Pilots Point Marina in Westbrook Center, Connecticut. You requested the inspection to establish its condition and value.

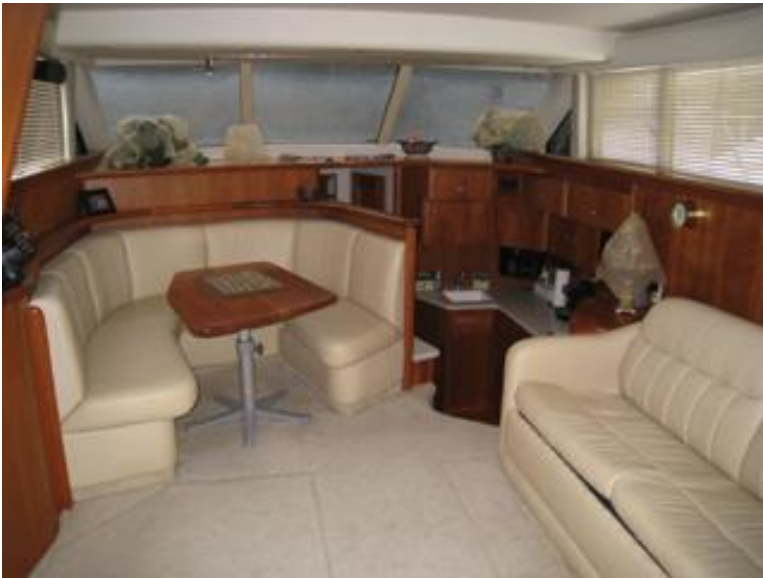
The main cabin houses the salon-dinette and galley. The berths and heads are forward and below. This area is spacious, nicely finished and in very good to excellent condition. The entire area is carpeted with a plush, color keyed, mold resistant nylon material. The carpet is protected with a nylon liner. The vinyl headliner is clean, in very good condition and secure. The upholstered sections, bulkheads, and joiner work show light use, very good care and maintenance. The interior joiner (other than the liner) work is plywood with a veneer and is has a very well maintained finish. The main salon is equipped with heat and air conditioning. Custom blinds, curtains and draps. lockers and storage space is adequate. Hatches and ports are tight to the weather and secure.

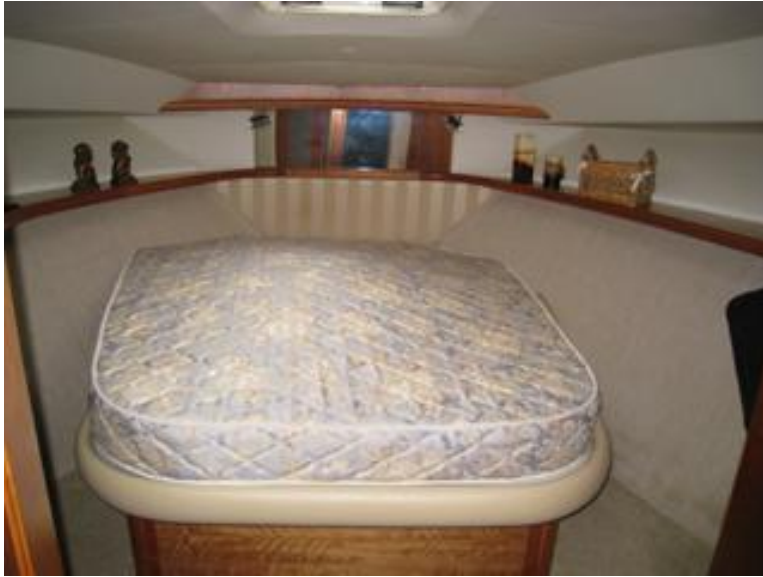
The forward berth is located beneath the forward deck. This area will sleep two in a custom shaped over size queen berth. The forward berth area is clean. There is adequate lighting and ventilation in this area. Also, housed in this forward berth area are several lockers and drawer storage. Hookup for a TV/VCR is installed. A translucent overhead escape hatch and ports provide ventilation and light. The

hatches and ports appear tight to the weather and are in good condition.

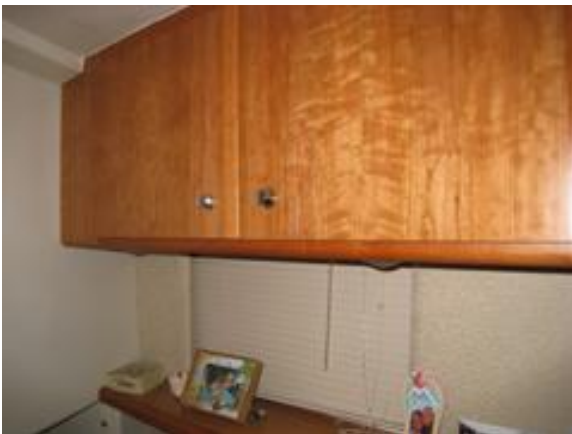
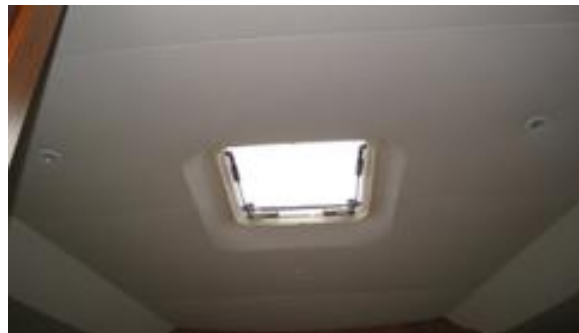
The crew's berth areas (aft of the forward berth and pictured at left) will sleep two, and are in about the same good condition as the forward berth. The upholstery is off for winter and the mattresses are in good, clean condition.

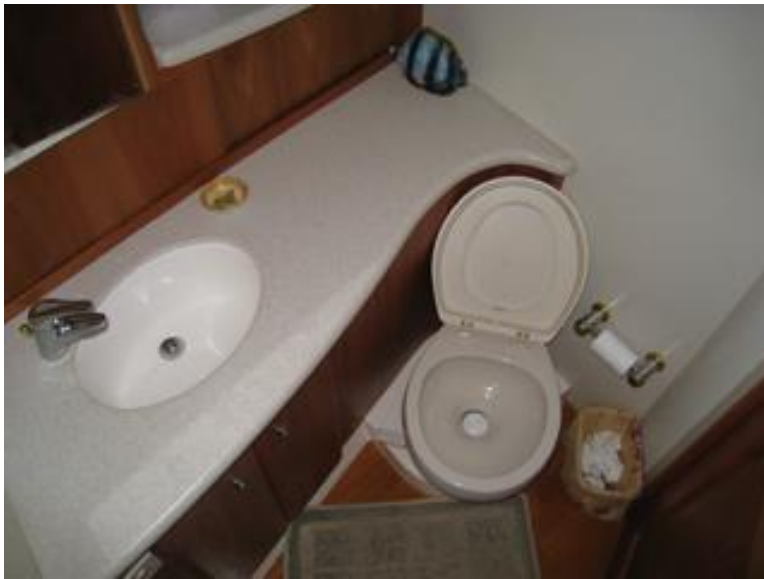
There are two separate compartments for the head and shower, both in very good condition. They are equipped with a standard electric marine toilet, shower and hand basin. The shower unit is an integral part of the inner liner. The shower drain into a sump and then pumped overboard. From the appearance of the plumbing, carpet, and other fixtures, including the galley gear this vessel has been lightly used, and certainly not abused. A plastic holding tank and related Y valve and plumbing are included. The hot and cold fresh water system looks good, but was not checked out.

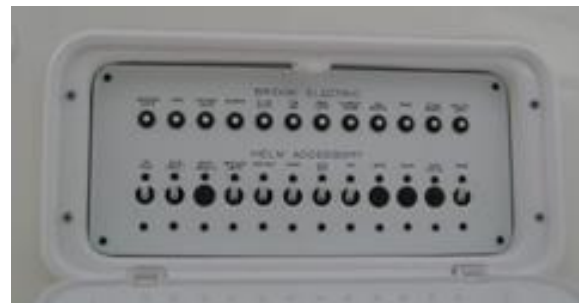
The combination AC/DC and AC generator power panel is mounted in the main salon and is easily accessible. The breakers and circuits were found to be in good condition. All circuits were checked out and found to be in good operating condition. A satisfactory (factory installed) ground system is employed. Appropriate Ground Fault receptacles are installed in the galley and head. The depth finder and Standard VHF transceiver are in good working condition. There are battery disconnect switches mounted on a frame in the main salon, and they are in good condition and secure. The navigation lights conform to the CFR and ring out okay.
