Electrical, Electronics, and Navigational Equipment

Piping, Tanks, and Systems

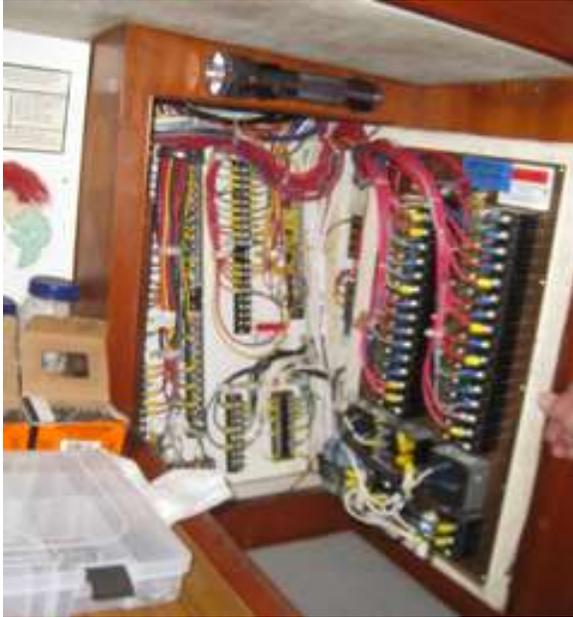
The batteries four (Deep cycle cells) appear new and are in good condition and properly connected to the approved three way switches and then on to the custom breaker panel. The batteries (Rolls) are properly boxed and covered. The wiring and terminals that could be observed are in good condition. The electrical wiring is properly harnessed. The shore power system overall is in good condition as are the cables. The automatic battery charger was not checked out. The navigation equipment and electronics, was not checked out. The electric anchor windlass is in excellent condition and secure. The Auto pilot hardware is properly installed and appears in good condition. All of the electronics devices were not checked out as a sea trial was not conducted. The navigation lights conform to the CFR and are working.
