Re: 2006 Southport Yamaha AR230

This letter reports the results of a survey of the above vessel which was inspected while hauled and afloat on the 5th of May 2011, at Webster Lake in Webster, Massachusetts. You requested the inspection to establish its condition and value.

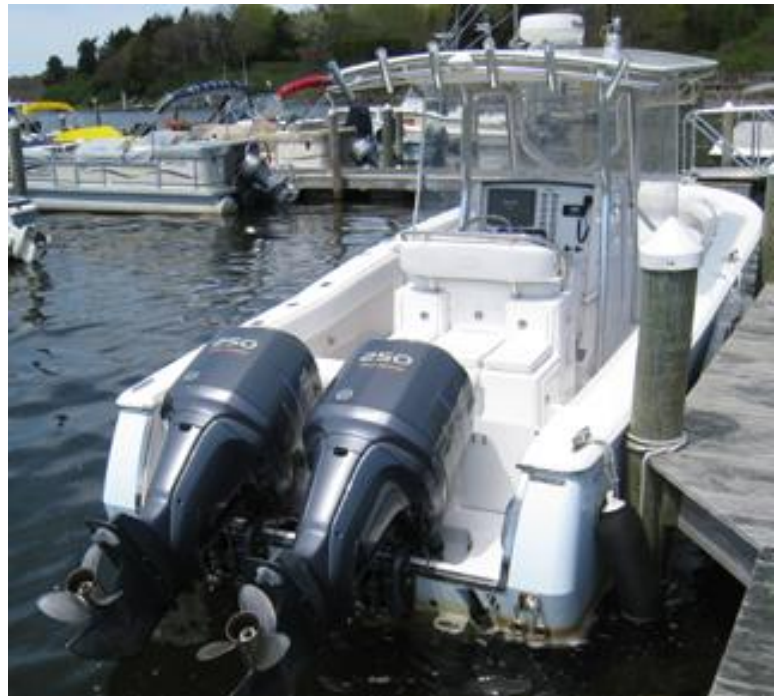
The vessel was built by SOUTHPORT BOAT WORKS, AUGUSTA, ME, in 2006 . The vessel bears the hull ID number YAMCR249I405. The pertinent dimensions of the vessel are: The LOA is 23' , and the beam is 8' 6" and the draft is approximately 1' 4". The displacement is approximately 3000 pounds.

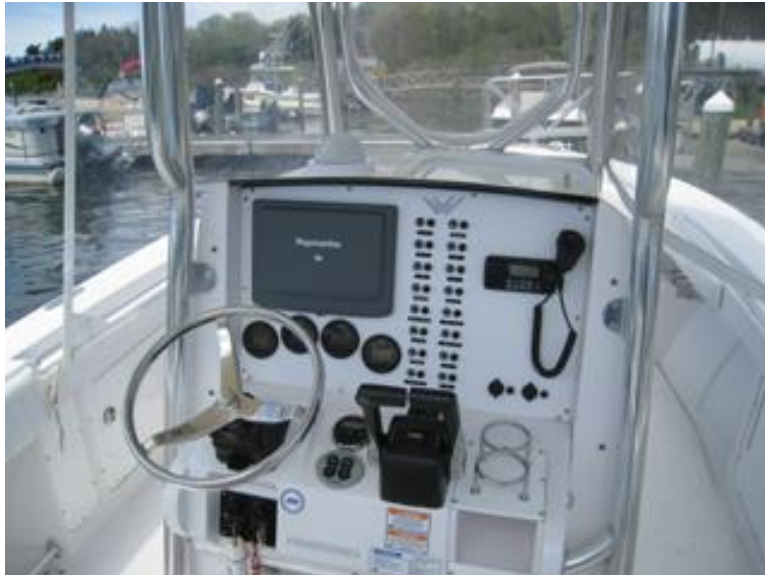
The hull is a polyester laminate reinforced with fiberglass mat and woven roving in a modified deep V configuration. The gel coat is red and white, and in very good condition, with a need for cleaning and waxing. The forward deck seating and related hatches are in good condition. The bow pulpit is also

in good secure condition. The bulkheads, as can be inspected, are glass tabbed to the hull. The glass tabbing throughout is secure. There is an inner liner throughout the vessel which comprises the view of the interior and this gel coated fiberglass liner is also in good condition. It is obvious that this vessel has had no abuse. The spaces, compartments, and voids, between the hull and inner liner are epoxy coated. Most of these areas are clean. The bilge is fairly clean. The topsides are white, and in good condition free of major mars and scratches. The towing structure and deck hardware are properly mounted and secure. The windshield and supporting structures are in good shape. The

steering apparatus is in good condition. All of the rails and cleats are properly secured and constructed of stainless. The navigation lights comply with CFR regulations. An adequately sized anchor and adequate rode is not provided in a locker at the bow. Ground tackle should be installed.

Recommendations: Install ground tackle, insure that a complete Coast Guard Safety and Signalling package is aboard.

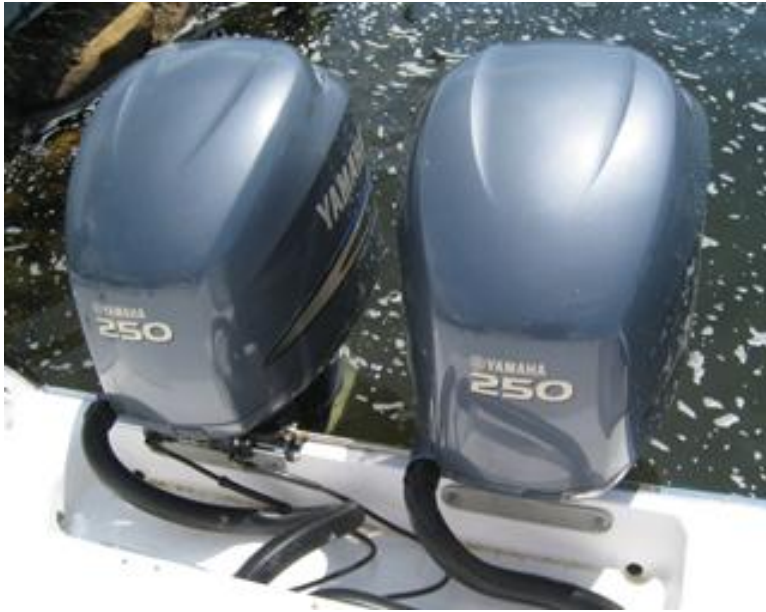
The cockpit is equipped with a canvas top (off for now). The supporting structure and top are in good condition. The

structure is properly backed at the attachment points. The wheel, gauges and controls are in good shape. The cockpit area is clean and the finish is in unusually good condition. The vinyl upholstery, including the bolstering, is also in good condition. The control panel and switches appear in lightly used condition. The fuel fill is properly installed and marked. There are a variety of wells and lockers built in aft, all are in good condition. Access to the battery switch is gained at the battery hatch.

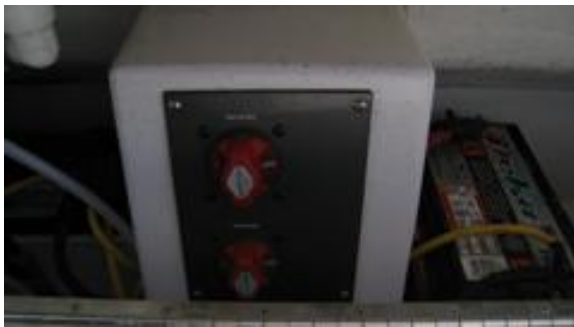
Propulsion is by two 140 hp fresh water cooled Yamaha engines with Jet Drives. Both engines started and ran with no hesitation. Visual inspection of the engines, oil, filters, and related connections show no signs of abuse. Visual inspection of the jet drives indicate no grounding or abuse of any consequence. Proper backfire flame arresters are installed. Approved bilge blower and hoses are installed and working. There is a bilge pump mounted and properly functioning.

The fuel tanks can not be completely inspected. They do appear properly secured and grounded, as are the related fills and vents. There is no fuel shut-off valve on the feed line.

There are no traces of oil in the bilge, and the bilge is clean overall. The overall appearance of the engine space is very good.

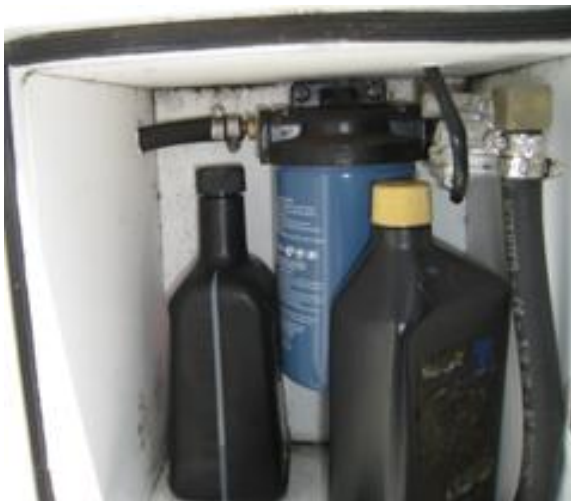
The aft gear compartment is clean, odor free, and free of any unessential material. It houses, among other devices, the battery and a three way switch which are in good shape. The battery is properly installed and secured and appears original. The battery connections are appropriate as are the cables. The electrical wiring and terminals observed throughout the vessel are in good condition. The throttle and gear linkages are in good order and work smoothly.

There is minimal wiring. It is protected and secure
